# Final Report of the VA Research Infrastructure Program

**Veterans Health Administration  
Office of Research and Development  
July 2012**

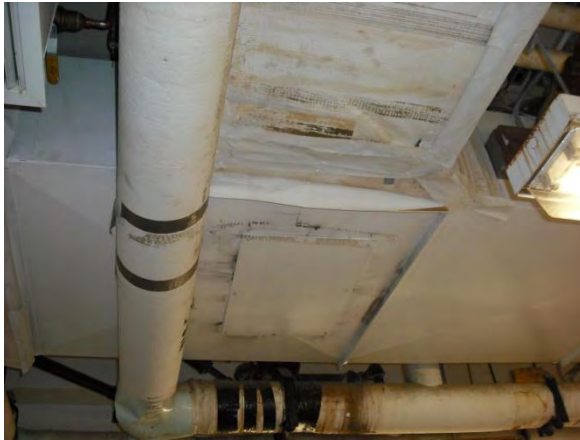
**The cage wash area in Bldg 7 has an inappropriate ceiling.**

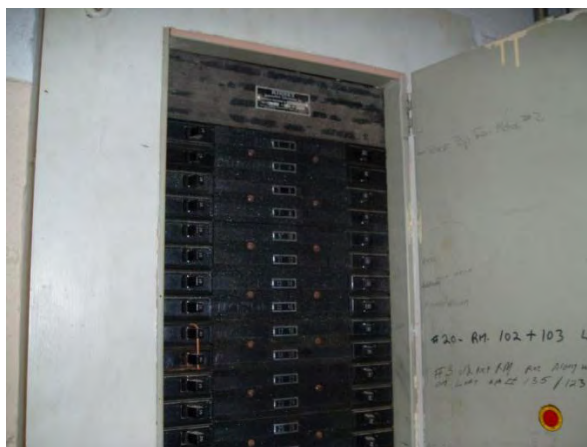
**Old style electrical panel in Bldg 46.**

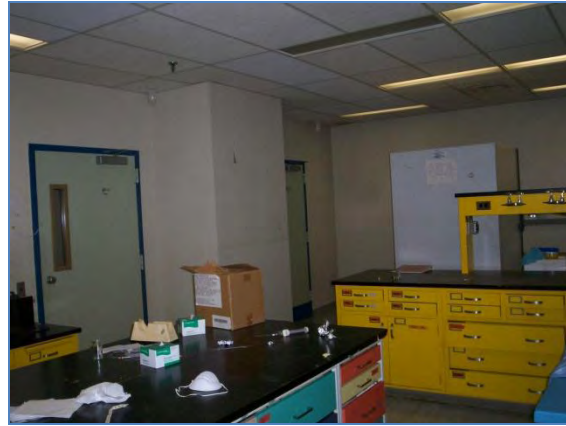
**Left photo: A renovated laboratory. Note the odd cut out area adjacent to the sink which has no apparent purpose. The right photo shows a laboratory that has not yet been renovated.**

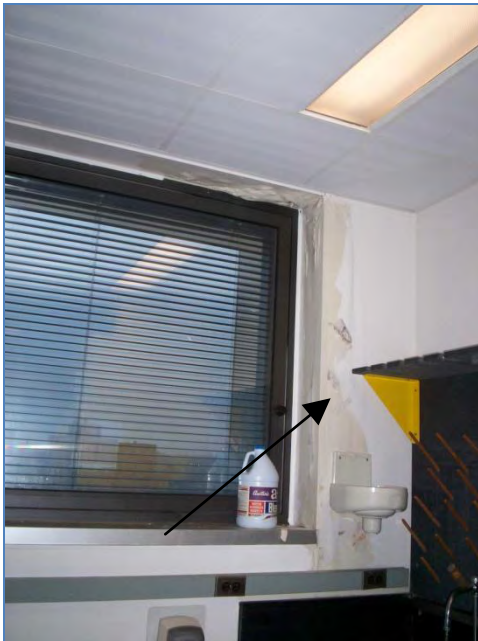
There is a significant problem with leakage around the windows, particularly at the northwest corner of the building where interior finishes are water damaged. All windows in the building need to be replaced.

**Water leakage around windows has caused significant damage to finishes.**

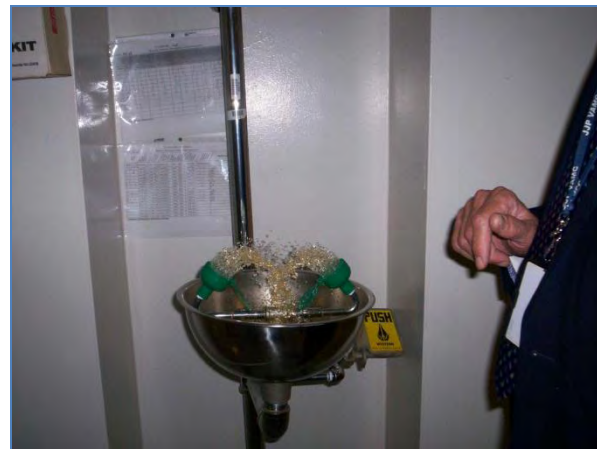
**Some emergency eyewashes produce discolored water due to pipe corrosion.**

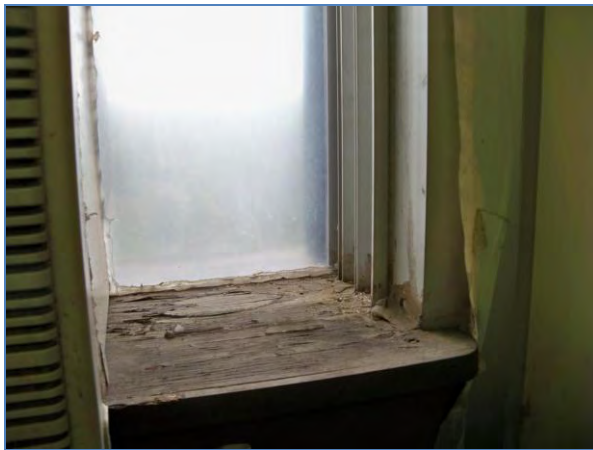
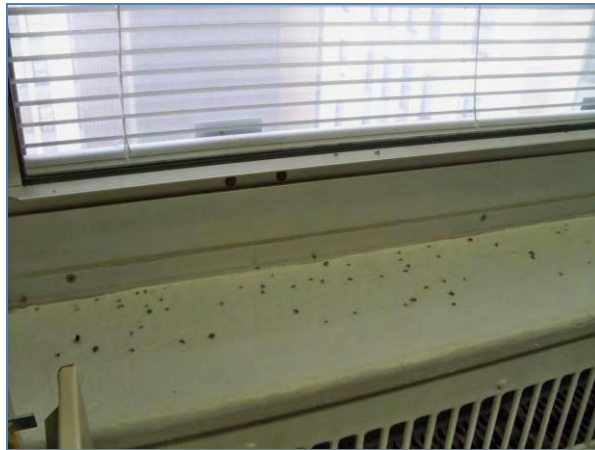
**Window and wall conditions in the Building 1 laboratories are generally poor. There also is evidence of insect intrusion on window sills.**

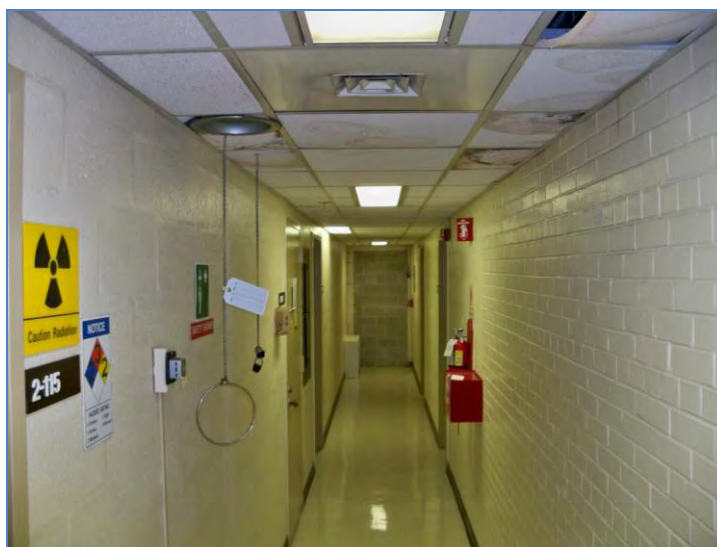
**In Building 11, a narrow corridor with ceiling panels showing water stains and mold.**

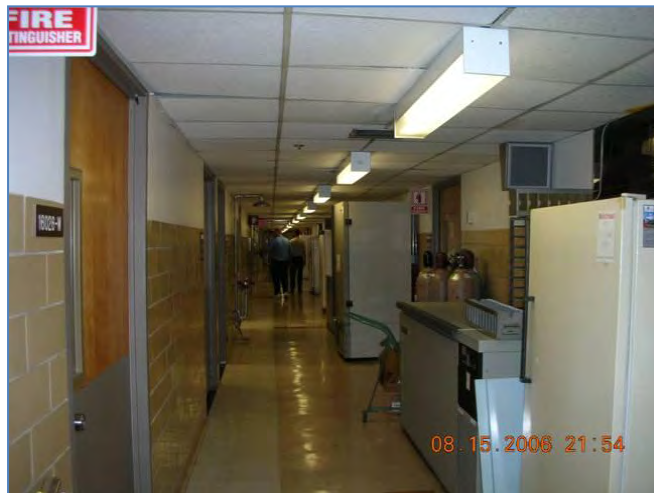
**Equipment stored in corridors creates crowded conditions and blocks egress.**

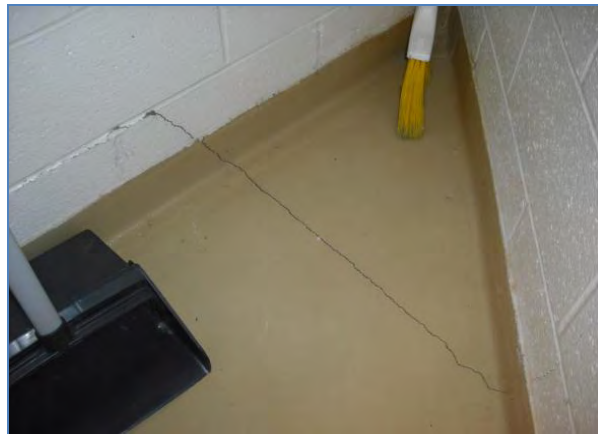
**Cracks from the exterior wall across the floor of Building 14.**

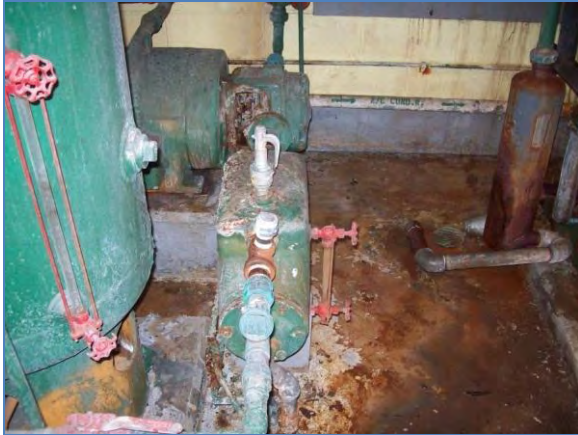
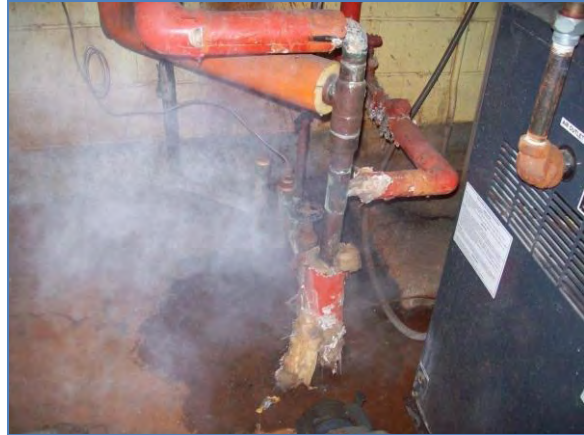
**While the laboratories are newly renovated, the building's support systems are severely aging and deficient. The photo at left is the compressed air system in poor condition. At right is a steam leak in mechanical space.**

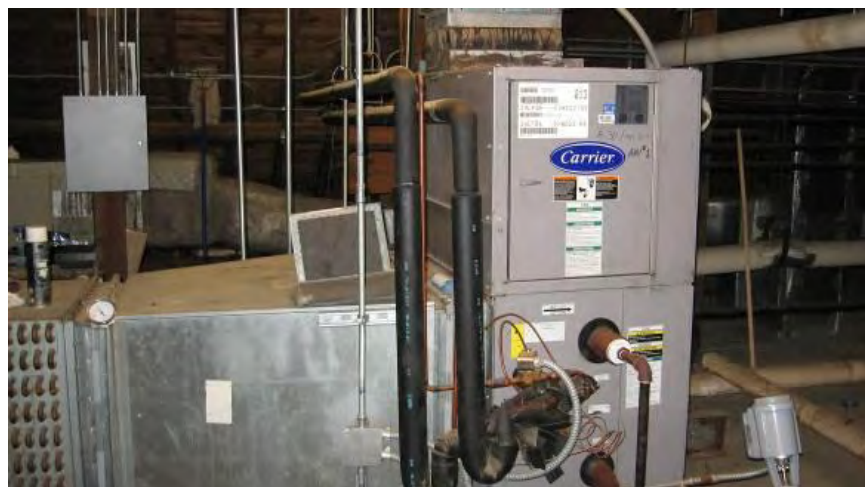
There are a number of deficiencies with the mechanical system. Air handling units as well as the air distribution system serving Building 9 are in poor or failing condition and should be replaced. The smaller air handling units serving the VMU are also in need of replacement along with their duct systems. There is emergency power for the cooling and ventilation system in Building 9, but no redundancy in the event of equipment failure. The rooftop stacks for the exhaust system are inadequate, although the exhaust fans are in fair condition.

**During the assessment, air handling units serving the original part of the building as well as the VMU were found to be in failing condition.**

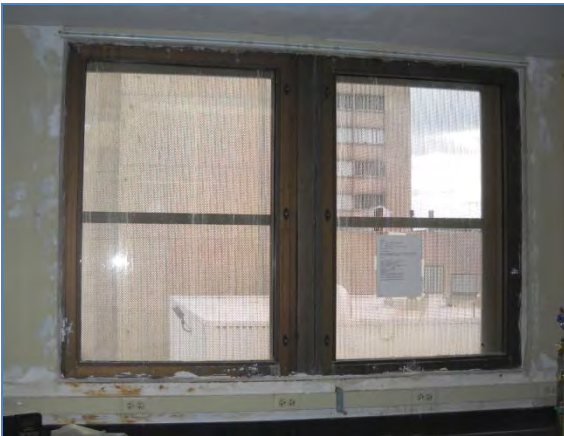
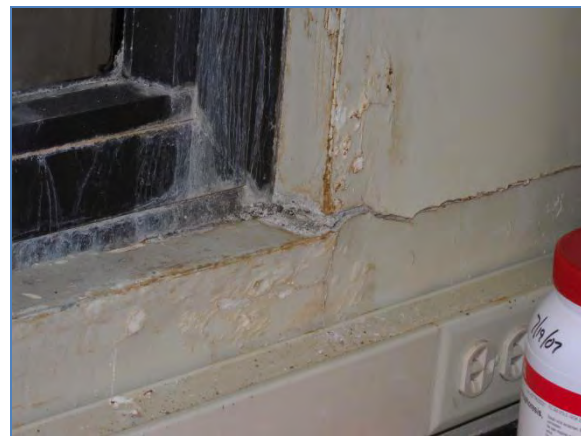
**In Building 7, there is extensive leakage around the exterior windows that has caused significant damage to interior finishes.**

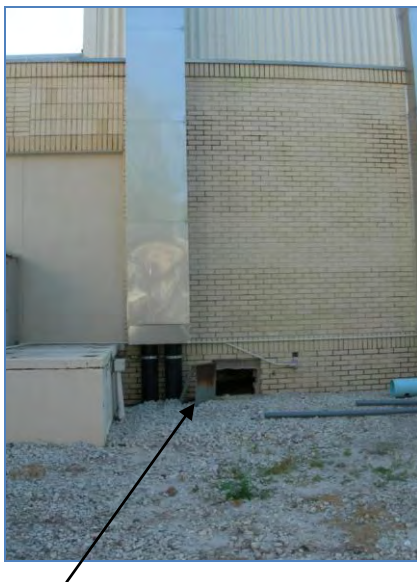
**The open hatch at the base of the exterior of Bldg 11 provides a potential inlet for vermin.**

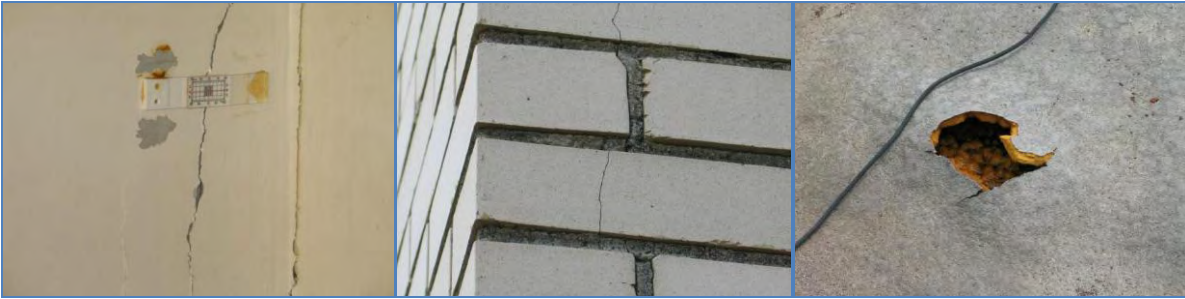
**Examples of (left to right): interior cracking, exterior cracking, roof deterioration.**

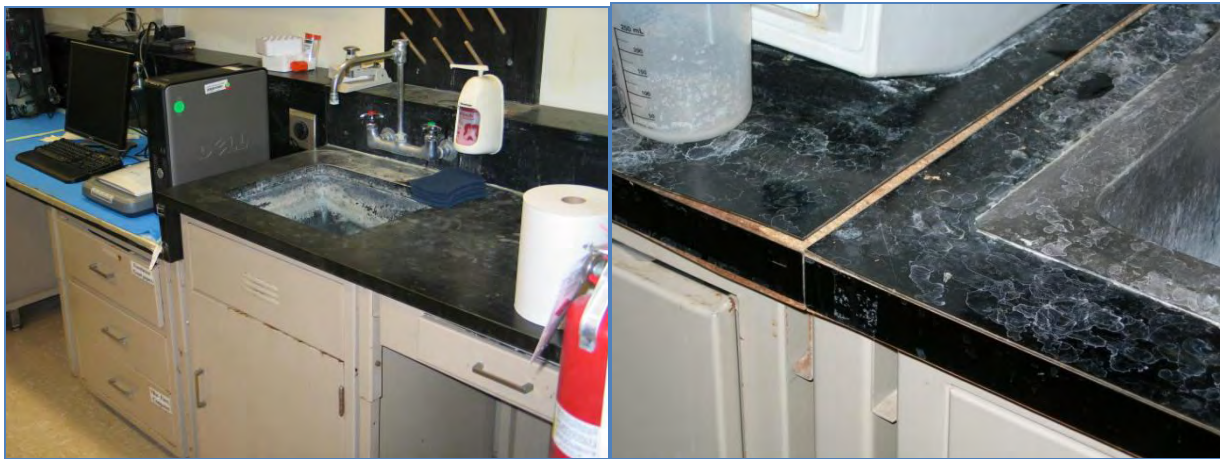
**The photo at left depicts typical condition of casework in the laboratories. The photo at right show what can happen when an inappropriate finish (plastic laminate countertop) is used in a laboratory environment.**

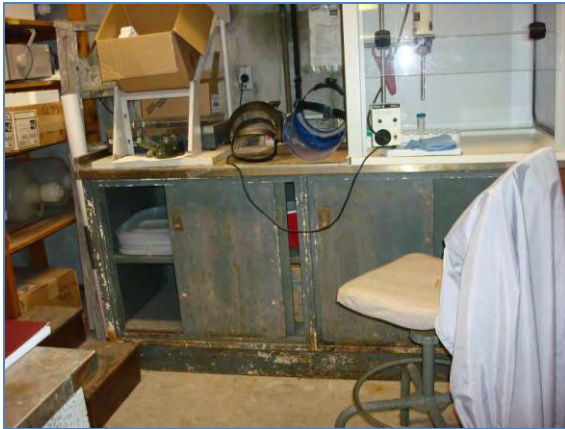
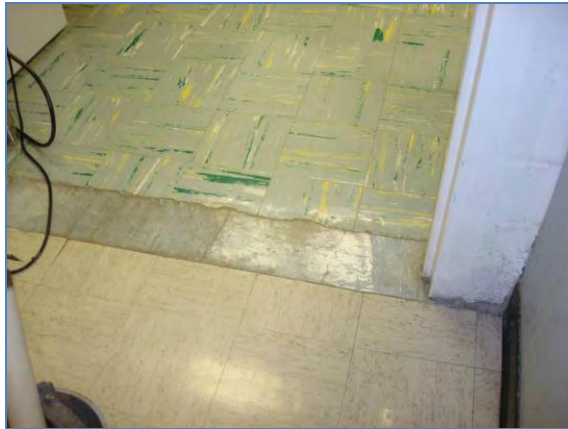
**By contrast, Building 19 is in poor condition and not suitable to house research laboratories. The photo at left shows what is likely the worst laboratory in Building 19. The photo at right shows vinyl asbestos tile flooring in Building 19.**

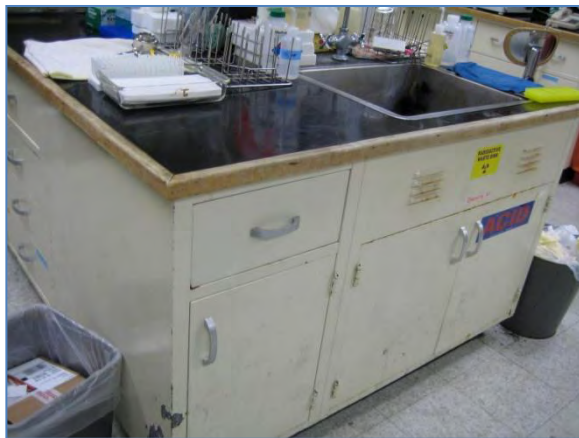
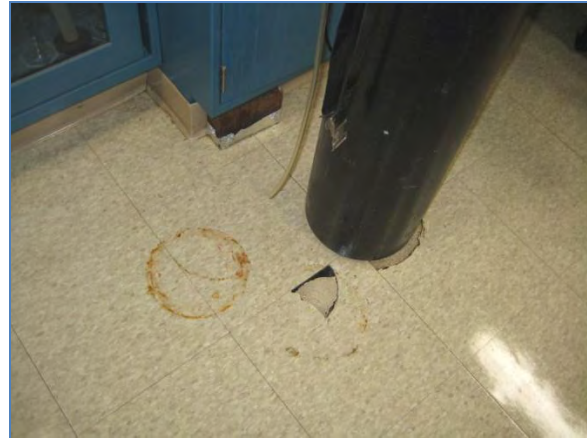
**The photos above and below show Building 1 laboratory space in disrepair and in need of significant renovation.**

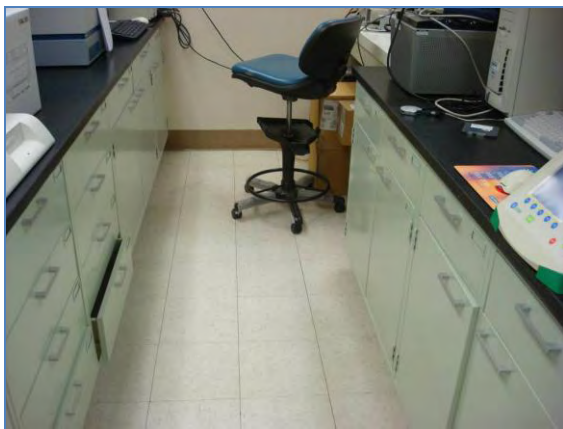
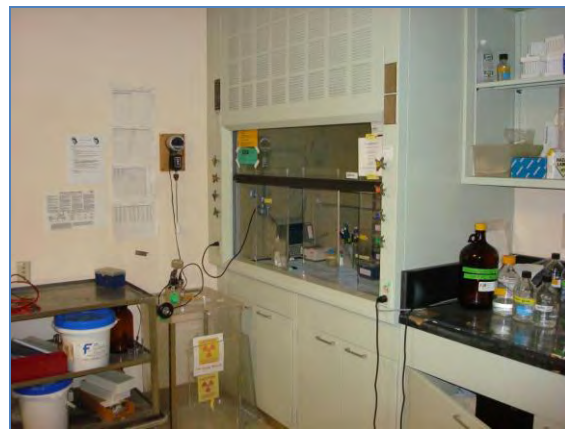
**Laboratories in Building 1 were retrofitted into former clinical space. There are insufficient clearances between benches (left photo above) and general overcrowding due to lack of sufficient storage space.**

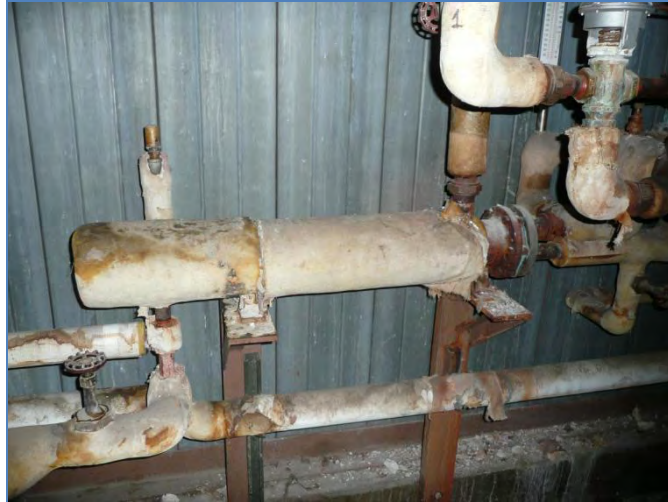
**The space in Buildings 22 and 31 are dramatically different. The photos above of Building 22 are indicative of the space and the systems having had little or no updates in the past 40 years. (Left: a typical Bldg 22 laboratory; right: the heating hot water heat exchanger that is original to the building.)**

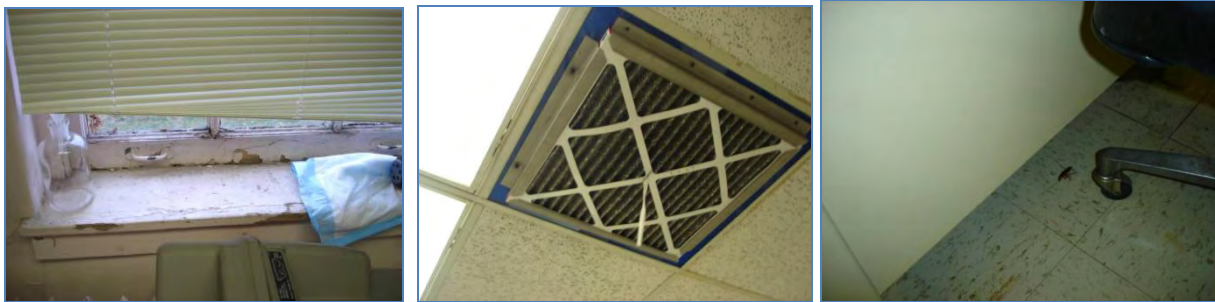
**Examples of the poor conditions in Building 1 include (above, left to right): Some original exterior windows remain on the building; a laboratory user's solution to friable insulation dust coming from diffusers; and a dead roach in a laboratory.**

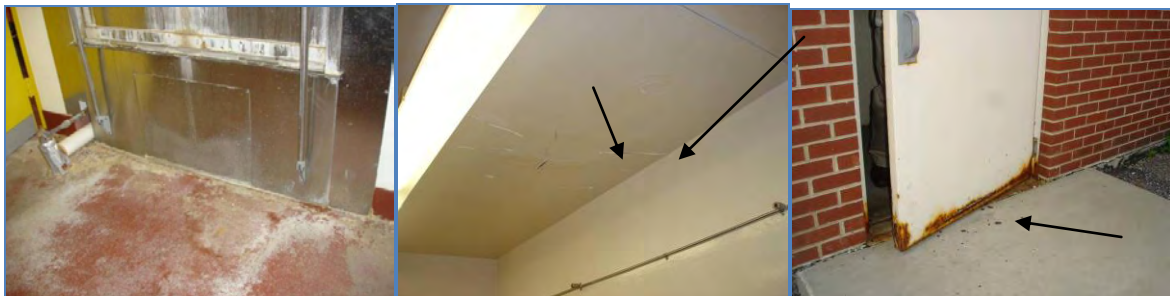
**Damaged finishes in the VMU include (left to right) flooring in front of the cage washer, ceilings, and an exterior door.**

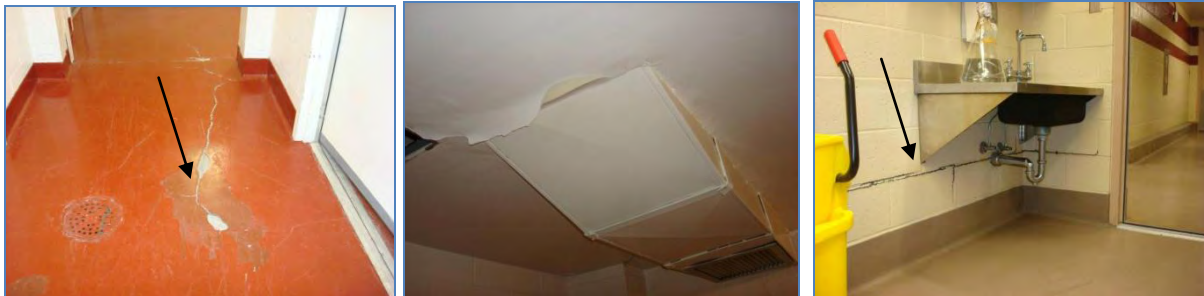
**The photos above show damaged finishes in the VMU. From left to right, damaged epoxy floor; peeling paint on a ceiling; and a significant wall crack. The photo below shows corroded casework in an animal procedure room.**

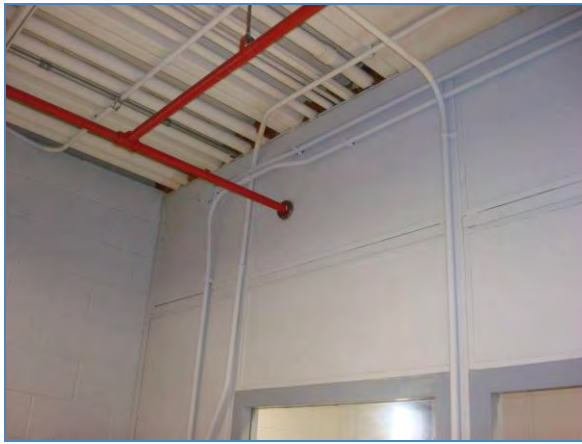
**In Building 15, a laboratory with no ceiling and a wall of temporary panels.**

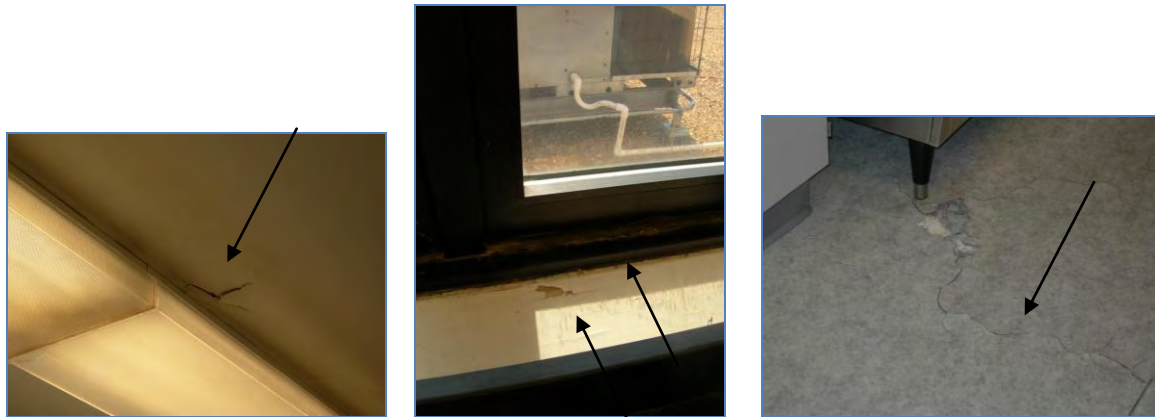
**The photos above show damaged finishes in Building 1 research space.**

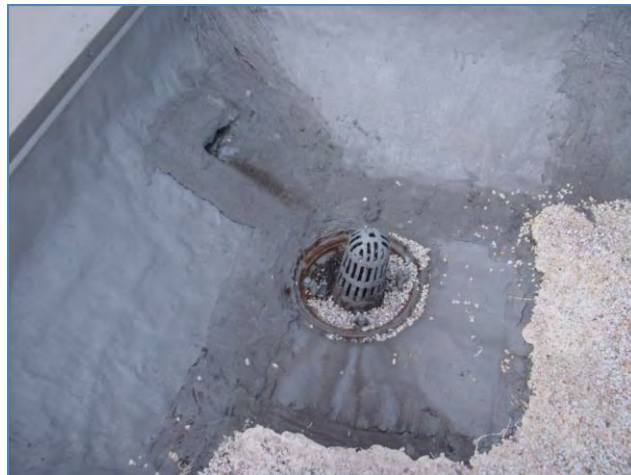
**Damaged roof membrane, Bldg 6.**

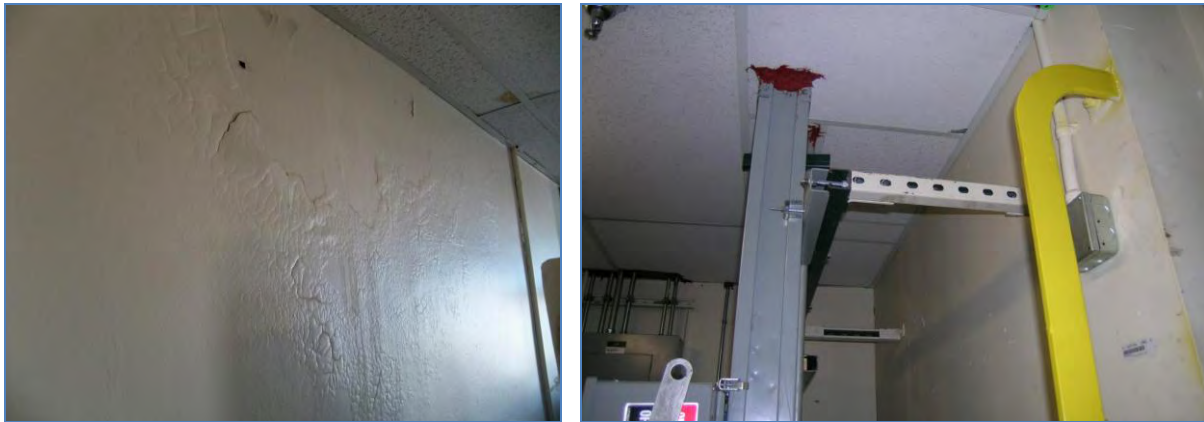
**In Building 1, some wall finishes are damaged due to water leakage (left photo). The right photo shows piping and support penetrations with fire sealant at the acoustic ceiling. This will not provide a fire separation.**

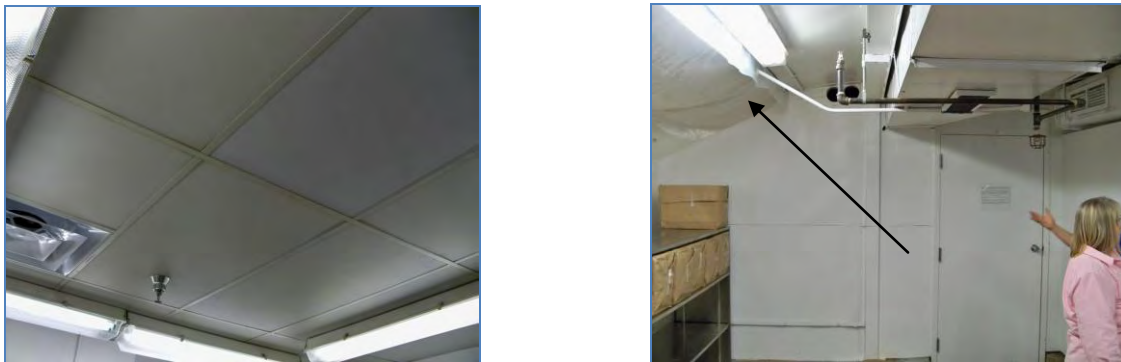
**Two views of the VMU in Building 19. At left, the metal ceiling grid is rusting and is an inappropriate surface in an animal facility. At right, plastic (at the arrow) is protecting clean cages from leakage.**

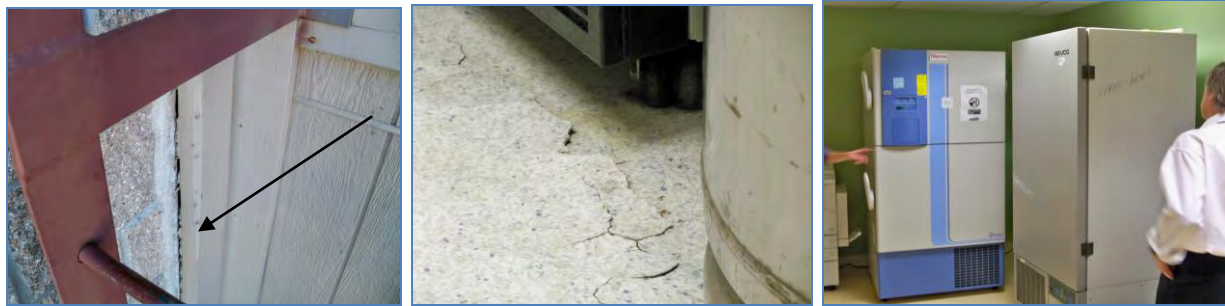
**As shown above, Building 23 does not provide a proper environment for research. From left to right, evidence of significant structural deficiencies (elevator shaft is separating from the building); damage to flooring caused by thermal shock; and Ultra-low temperature freezers located in a corridor, not connected to emergency power and not monitored for failure (during the assessment, one of them had failed without anyone knowing).**

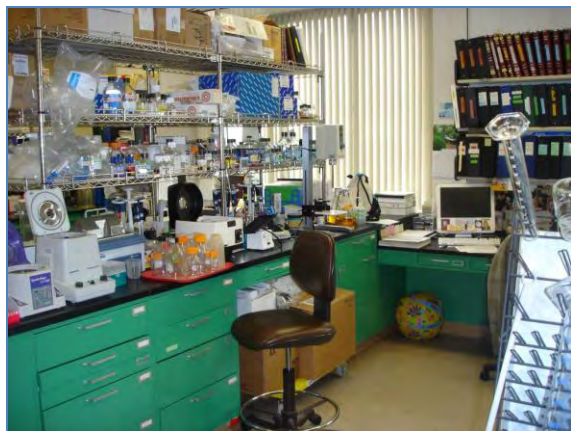
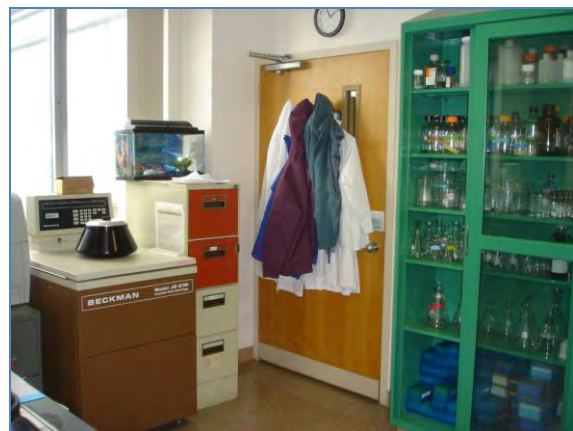
**The photos above show two views of typical Building 101 laboratory space. Note the crowded conditions due to lack of storage and equipment space, sometimes impeding accessibility.**

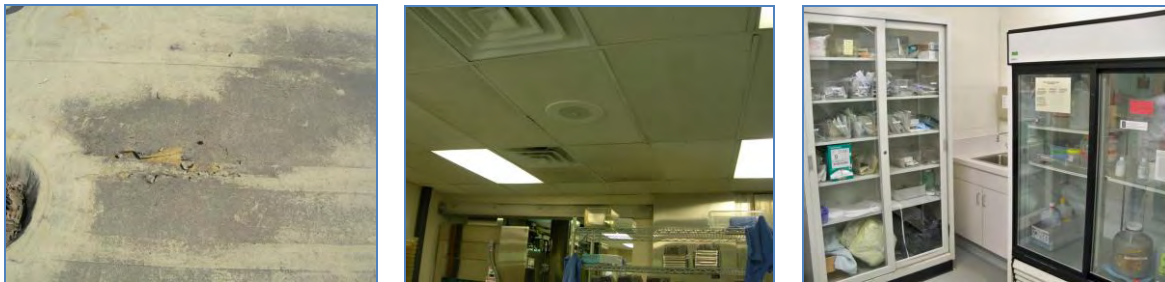
**Above, the animal research facility occupies space in three buildings. From left to right, roof damage on Building 13, an inappropriate ceiling finish in the cage wash area of Building 23, and an overcrowded procedure room in Building 34.**

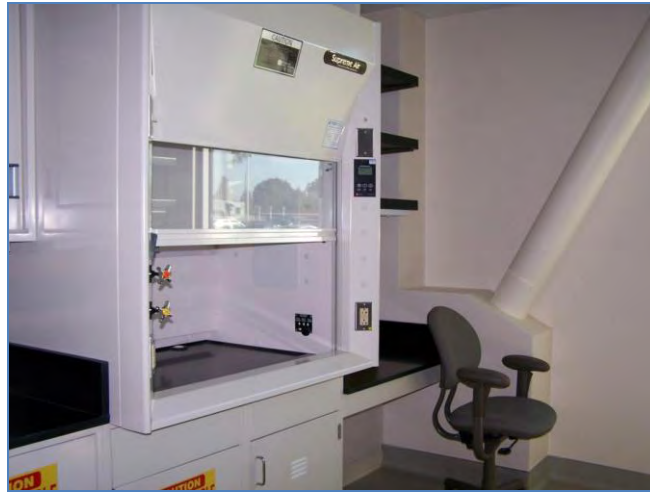
**Photos above show the new laboratory space in Building 51. This high quality laboratory has a potential egress problem with the work station located next to the fume hood. In case of emergency originating in the fume hood, there is no secondary egress for someone who may be working at the desk area. A similar situation exists in Building 101 (photo, bottom left). At bottom right, the laboratories in Bldgs MB3/MB4 are in poor condition.**

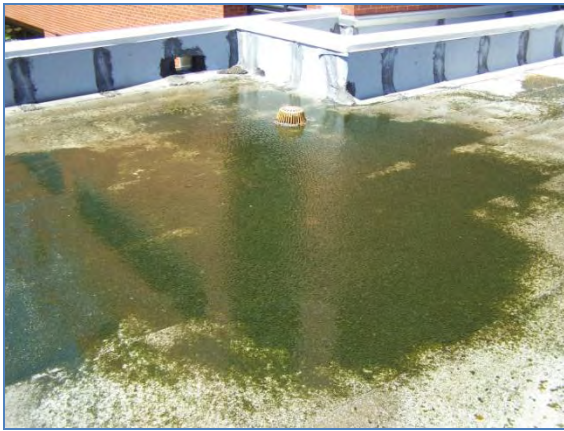
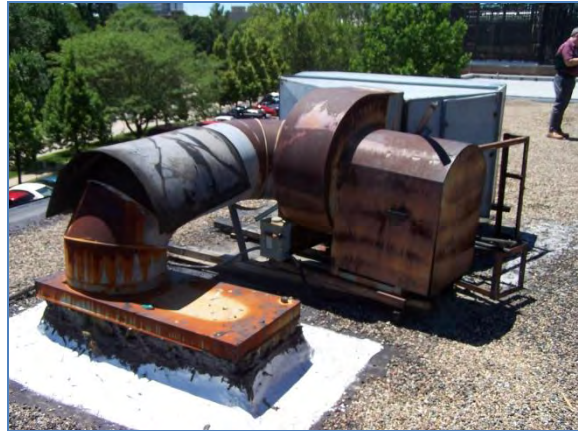
**Bldg 2: ponding water on the roof (left) and deteriorating exhaust equipment.**
