# Final Report of the VA Research Infrastructure Program

**Veterans Health Administration  
Office of Research and Development  
July 2012**

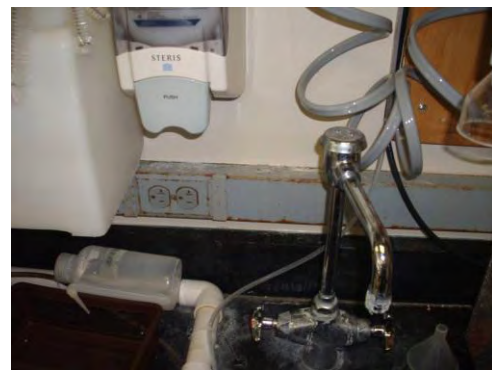
**Receptacles near sinks are not ground fault protected. Also note the rusted electrical raceway.**

The electrical systems, both normal and emergency power, are in fair condition. The distribution equipment is original to the building, has had little or no documented preventive maintenance, and is in need of replacement. There also is no transient voltage surge suppression (TVSS) equipment to protect sensitive electronic equipment, nor is there ground fault protection on receptacles near sinks.

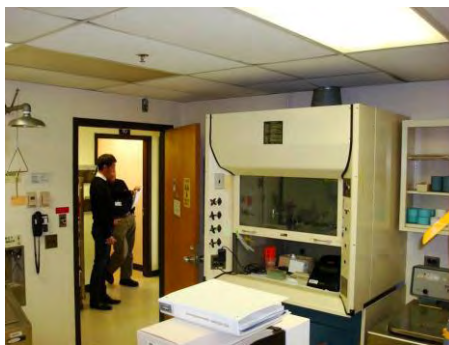
**Fume hood blocking laboratory egress, Bldg T-44.**

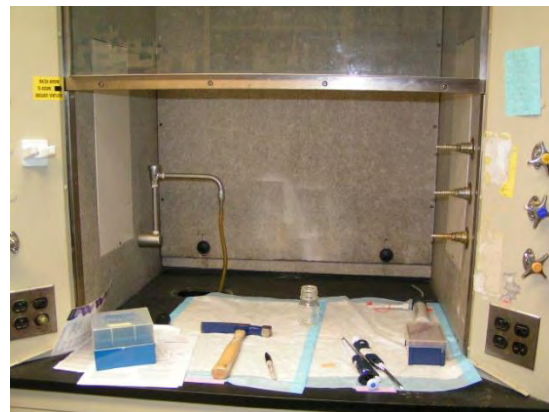
**Asbestos lined fume hood in second floor laboratory.**

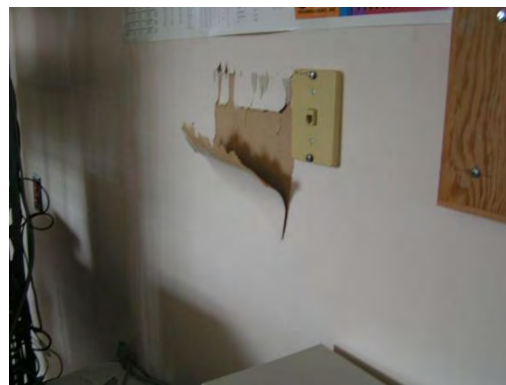
Building 70 has in the past and continues to suffer from extensive water damage due to leakage of the roof as well as the exterior envelope. Many wall finishes are severely damaged, some to the point of the room being closed for use until significant repairs can be made. The biomedical laboratories have poor quality casework and fixed equipment, as well as an electrical system in need of significant upgrade or replacement. As with Buildings 17 and 18, the HVAC system is not appropriate for a laboratory environment.

**Damage to wall finish caused by water leakage.**

Corrected roof leakage, Building 70 – (station funds), completed.

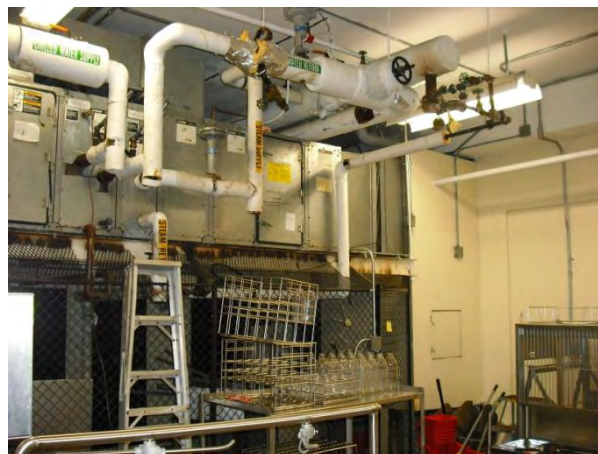
**In the VMU, there is no wall between the cage washer and HVAC equipment.**

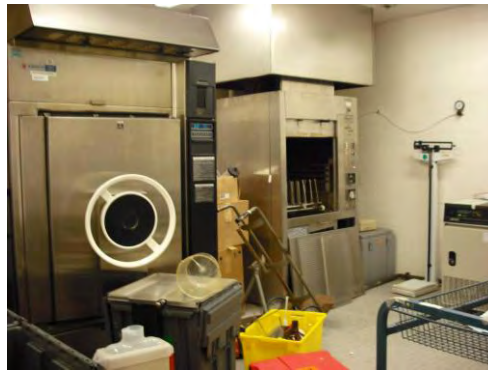
**The autoclave and glassware washer in Bldg 3 are in fair condition, but are reaching the end of their useful lives.**

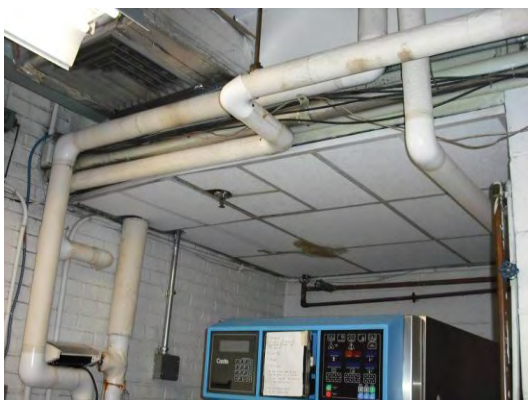
**An inappropriate ceiling in the autoclave room, Bldg 20.**

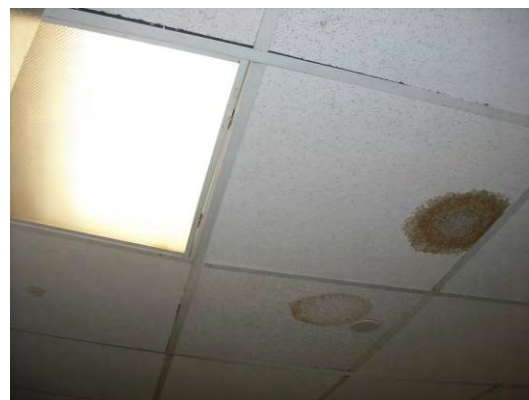
**VMU space should have hard ceilings, not acoustic tile. This tile ceiling is damaged. Also note the lack of a gasket on the lighting fixture.**

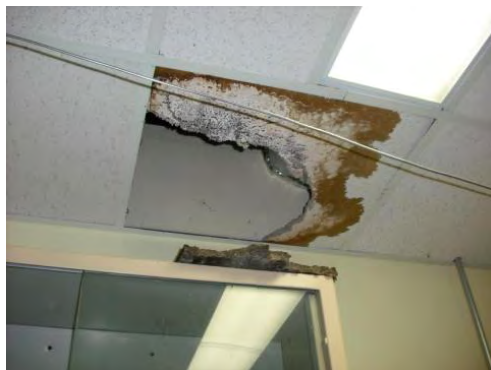
**Ceiling damage in Bldg 44.**

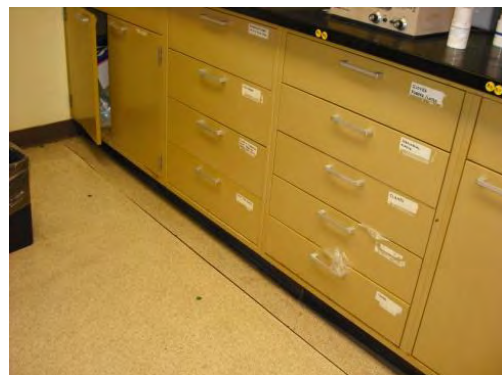
**Damaged flooring and rusted casework in Bldg 44.**

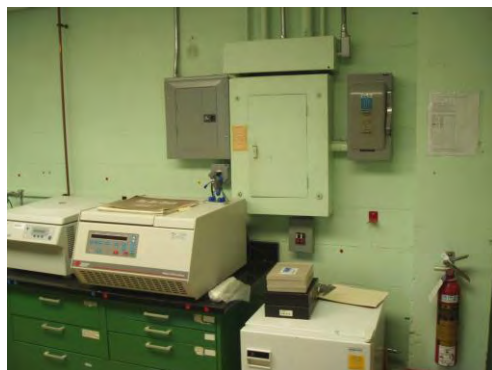
**Access to electric panel blocked by equipment in Bldg 44.**

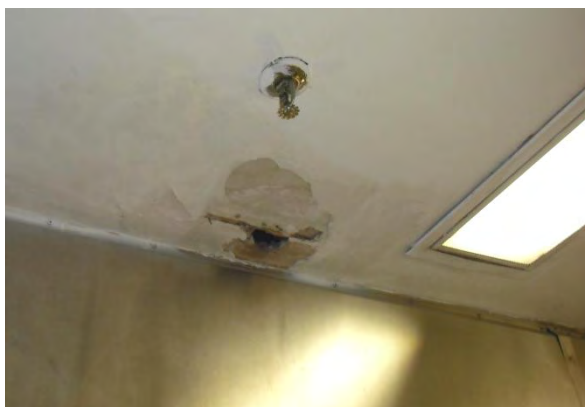
**In Bldg 46, damage to an animal holding room ceiling.**

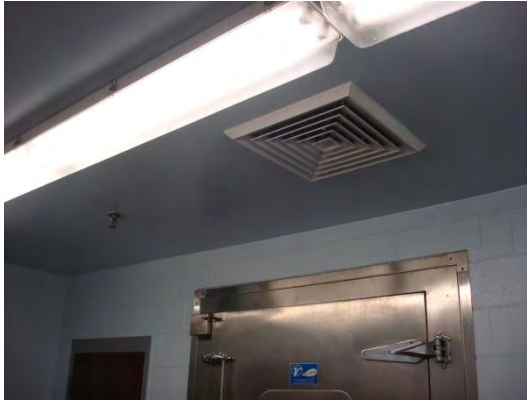
**Left photo: There is no exhaust canopy over the cage washer to catch steam when the cycle is complete and the door opened. This will result in damage to finishes within the cage wash area.**

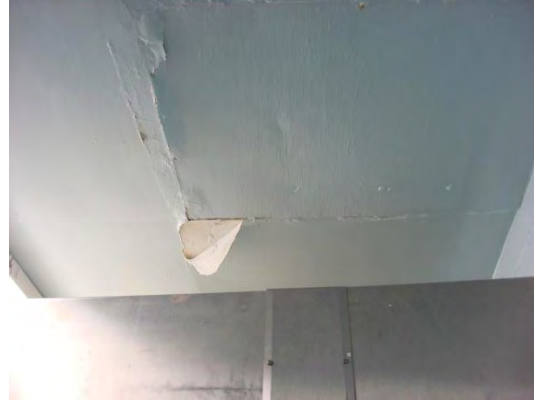
**Right photo: The ceiling in the cage wash area is already showing damage from excess steam filling the room.**

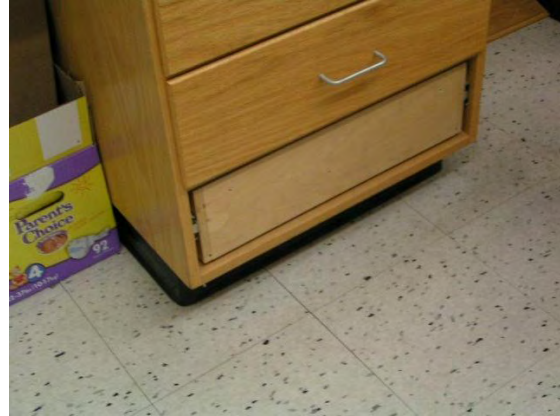
**The wood casework in Bldg 35 is not of an appropriate quality for use in research laboratories.**

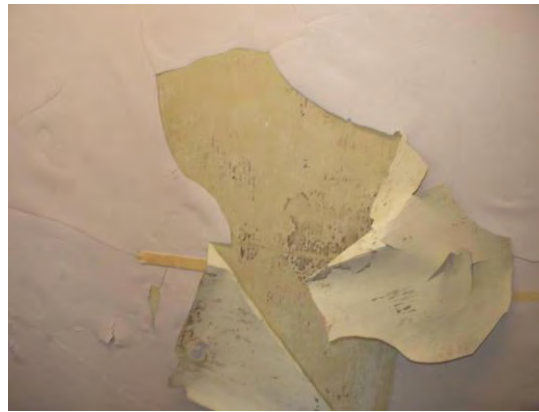
second floor is not in much better shape. Mold is present in the building and the systems are in need of replacement.

**Examples of water damage to walls and ceiling in Building 7.**

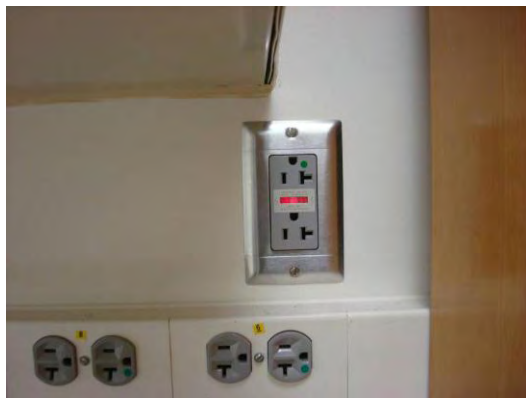
**A receptacle protected with transient voltage surge suppression (TVSS).**

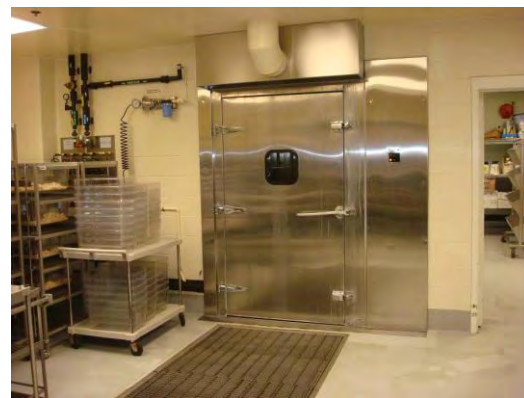
**The cage washer in the VMU has been refurbished since the time of the assessment.**

Fixed equipment in the laboratories is, for the most part, in good operating condition. There are two dishwashers in need of replacement and, in the VMU, the cage washer is aging and should be considered for replacement in the near future. (Note: Since the assessment, the cage washer has been refurbished.)

Correction of Priority 2 deficiency, cage washer in VMU beyond useful life – (VACO ORD funds for refurbishment), completed.

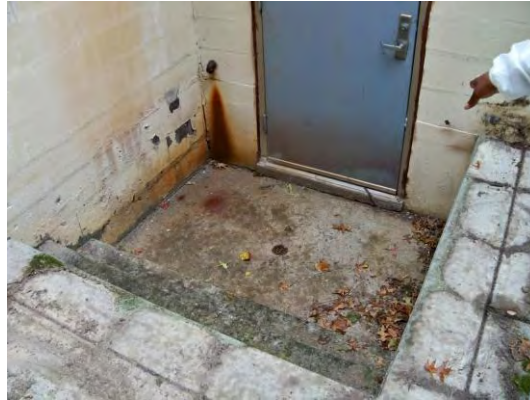
- The basement VMU is below grade and is subject to severe flooding. The facility has used sandbags around the building near exits in an attempt to stop water infiltration, but without much success. It was reported that after a heavy rain, as much as two inches of water can be standing throughout the basement.

- The flooding issues with the basement pose another serious problem, i.e., it can be difficult to open the exterior doors when there is water outside. Additionally, the sandbags can drift in front of a door blocking egress.

**Left photo: The foundation wall in the basement of Building 7 is cracking and showing signs of water pressure from the exterior. At right, an egress door from the VMU where water builds up after it rains.**

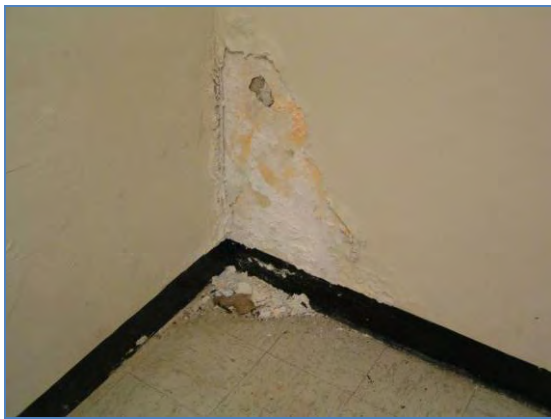
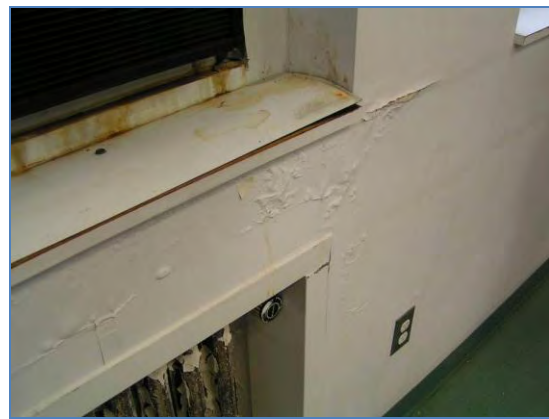
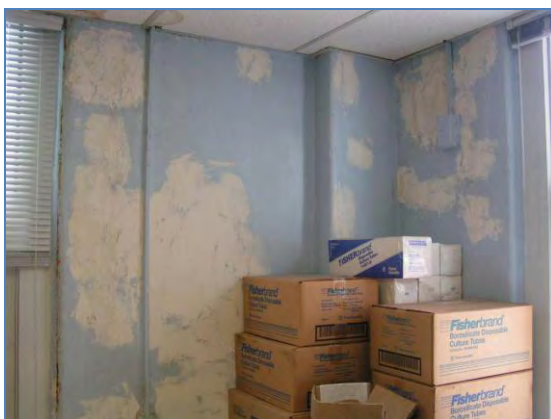
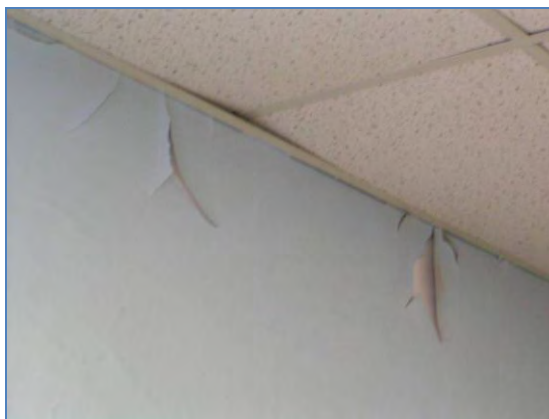
**The four photos above show examples of water damaged finishes in Building 61.**

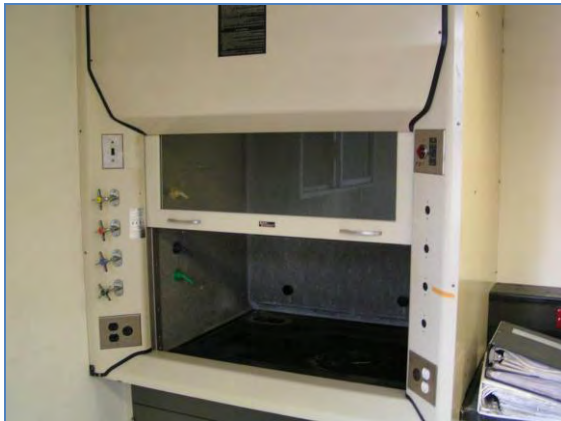
**In Building 62, a newer fume hood in a recently renovated laboratory.**

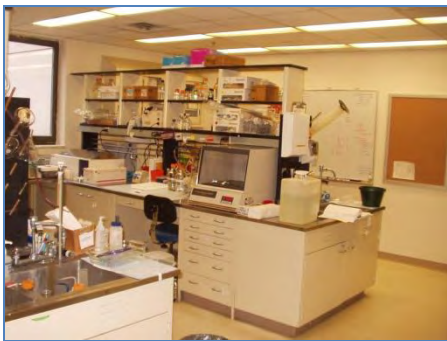
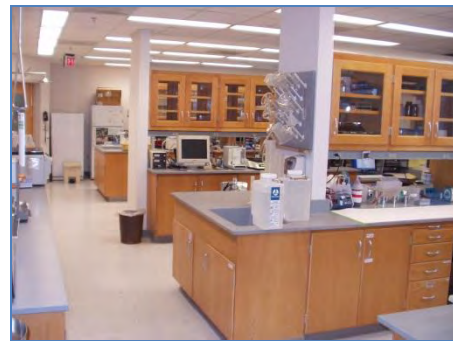
**The photo at left shows a typical non-renovated laboratory on the second and fifth floors. A renovated laboratory is shown in the photo at right.**

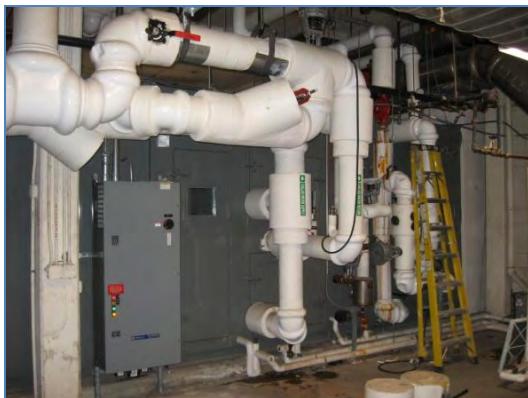
**A new air handling unit serving the research space.**

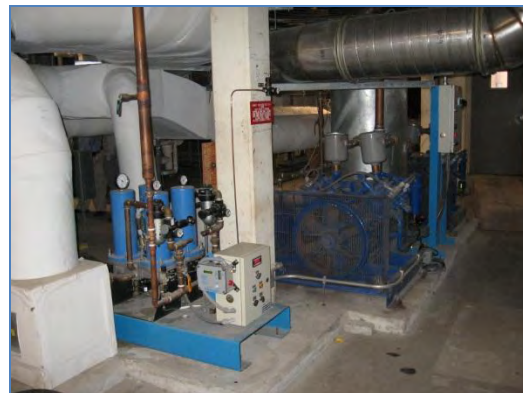
**New laboratory vacuum pumps. This station has consistently upgraded systems when renovating laboratories.**

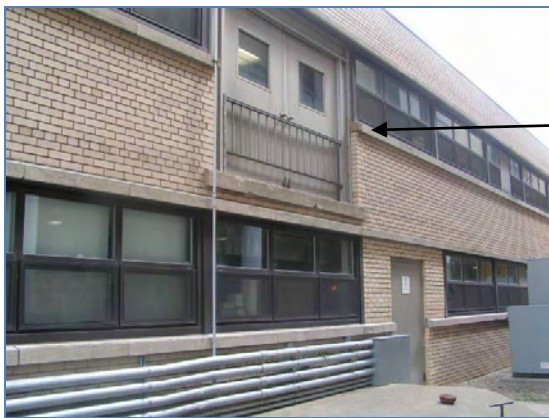
**In Building 6 equipment delivered for use on the upper floor must come through this exterior second floor door. There is no elevator in the building.**

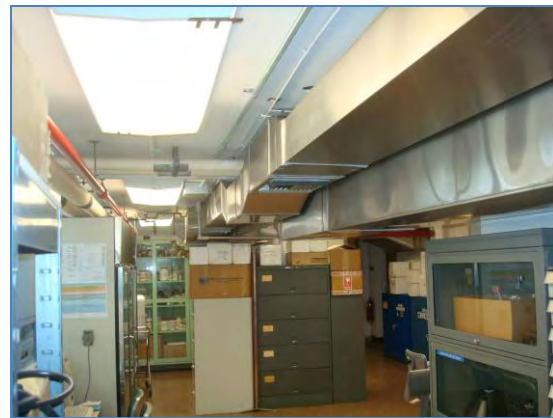
**Building 6 has many challenges. This very low exposed ductwork is one of them.**

One of the most challenging deficiencies in Building 6 is the lack of a ceiling, i.e., sprinklers, ducts, pipes, and conduits are exposed, some as low as six feet above the floor. Not only does this create potential hazards within the building, it also limits the potential for significant renovation. Another significant deficiency is the lack of accessibility both to enter the building and to access floors, as there are no ramps and no elevator. With the exception of an addition to the VMU which was added in the 1980s, door hardware does not comply with accessibility guidelines.

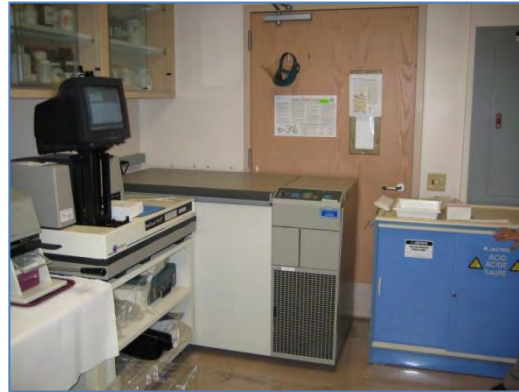
**Lack of space for freezers and other large equipment results in crowded laboratories and blocked egress.**

terms of the laboratories themselves is crowding due to the lack of adequate storage and support space for large equipment such as freezers.

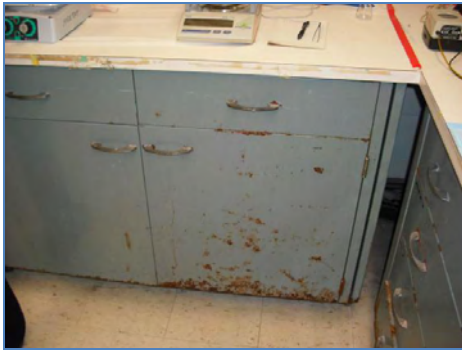
Generally, the finishes, casework, and fixed equipment in the Building 1 laboratories were found to be beyond their useful lives and in need of replacement. Some laboratories have bench tops of plastic laminate which is an inappropriate material for use in a laboratory. In many of the laboratories, the “ceiling” consists of a painted finish on the underside of the concrete structure above and, in some cases, the paint is peeling. There also is asbestos in the mastic used to adhere floor tiles.

**Example of corroded laboratory casework in Building 1.**

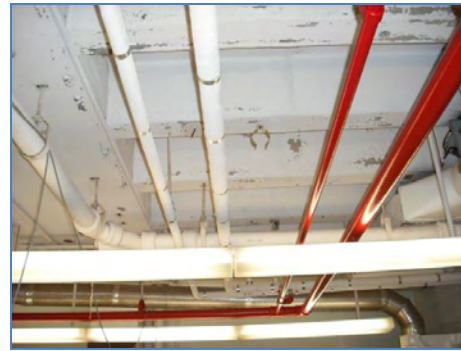
**Example of paint peeling from overhead structure in Building 1.**

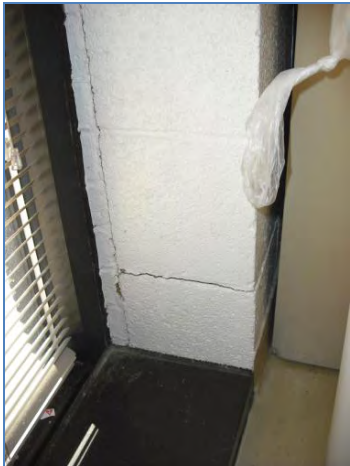
Just prior to the assessment, there had been excavation adjacent to Building 14 that caused some cracking and shifting of the foundation and exterior walls. The medical center undertook a detailed study of the problem that resulted in recommendations that had not yet been completed at the time of the assessment. There also were some roof leaks noted at the joint between the original building and the addition.

**Cracks in exterior wall, Bldg 14.**

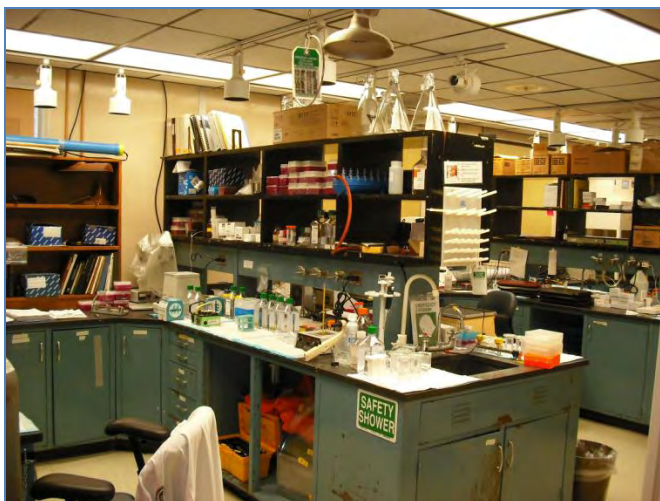
**A typical laboratory in Building 16.**

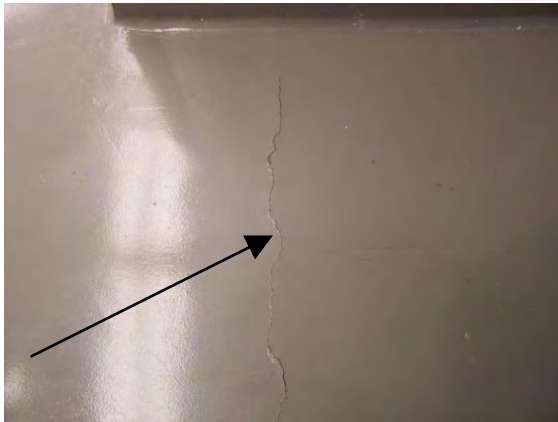
**Some cracking has developed in the epoxy flooring in the VMU.**

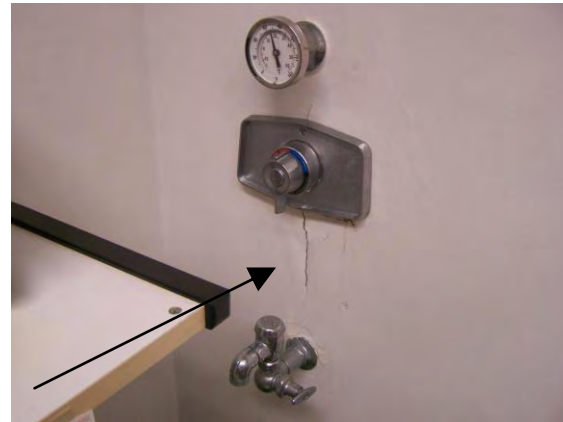
**Also in the VMU, this wall behind a faucet has developed cracks.**

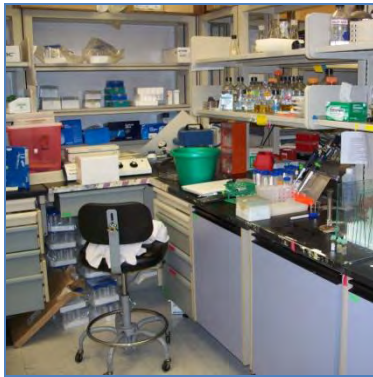
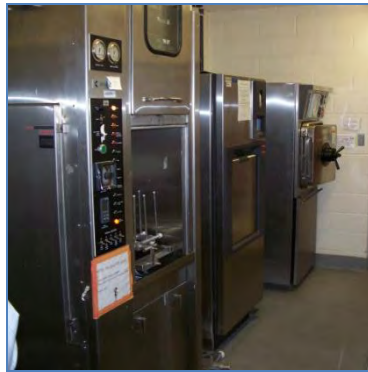
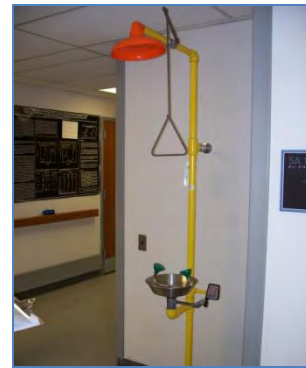
**Generally, the laboratories and support spaces in Building A are in good condition including casework and finishes, fixed equipment, and safety requirements.**

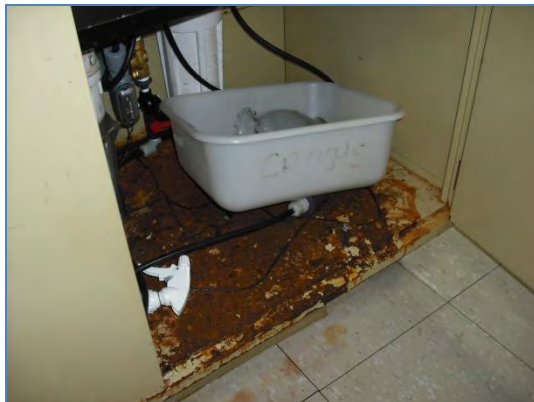
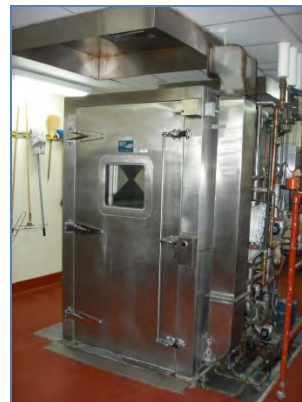
In the laboratories and the VMU, most finishes (walls, floors, and ceilings) are in good to fair condition. Some of the finishes in tissue culture spaces, such as the acoustical tile ceilings, are inappropriate as they can be difficult to keep clean. The metal casework is in poor condition. It is original to the building and is showing significant corrosion. The laboratories generally have a good layout with sufficient spacing between benches. There are no windows in the laboratories.

Most of the fume hoods are also original to the building and are in poor condition, although they are certified. There are some hoods with asbestos liners. The six walk-in cold rooms are all in failing condition and should be repaired or replaced. Several other pieces of equipment are in good operating order, including two autoclaves and a glass washer. In the VMU, the cage washer suffers frequent breakdowns and should be replaced.

**While many of the interior finishes are in good condition overall, the laboratory casework is original to the building and much of it is severely corroded, particularly beneath sinks. The VMU cage washer (right photo) is also original equipment and has frequent breakdowns.**

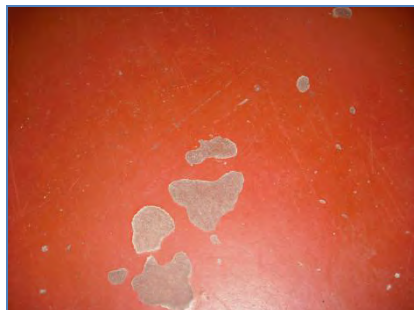
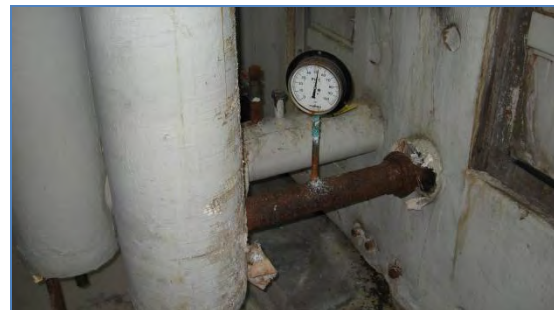
**(Left photo): In the VMU, some flooring is damaged. (Right photo): This chilled water pipe is severely rusted.**

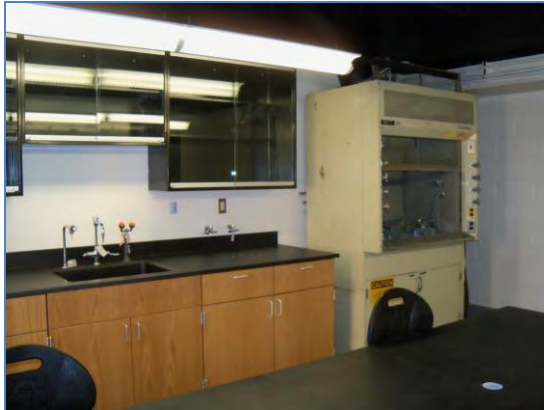
**Finishes, casework, and countertops in the newly renovated laboratories are in excellent condition. However, an aging fume hood has been placed in this laboratory.**

Only one of the new laboratories has a fume hood which, unfortunately, is an old, corroded unit that should be replaced.

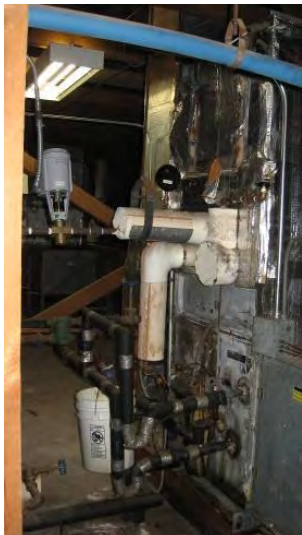
There are a number of deficiencies with the mechanical system. Air handling units as well as the air distribution system serving Building 9 are in poor or failing condition and should be replaced. The smaller air handling units serving the VMU are also in need of replacement along with their duct systems. There is emergency power for the cooling and ventilation system in Building 9, but no redundancy in the event of equipment failure. The rooftop stacks for the exhaust system are inadequate, although the exhaust fans are in fair condition.

**During the assessment, air handling units serving the original part of the building as well as the VMU were found to be in failing condition.**

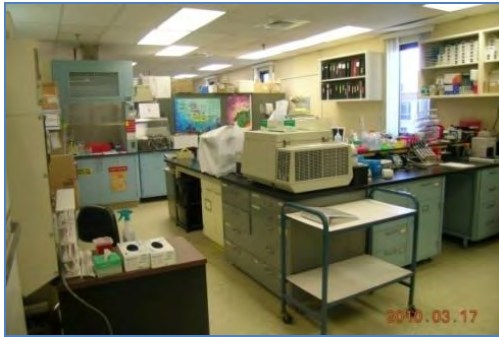
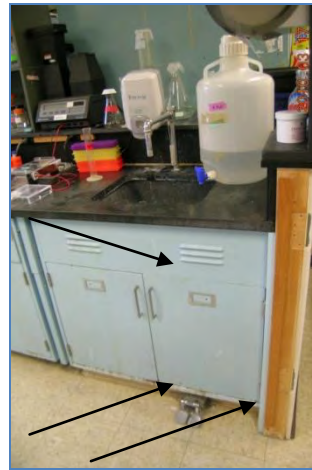
**The photo at left shows a typical laboratory in Bldg 23, with the original fume hood in place. Shown at right is the condition of casework, typical throughout the space. Note the corrosion.**

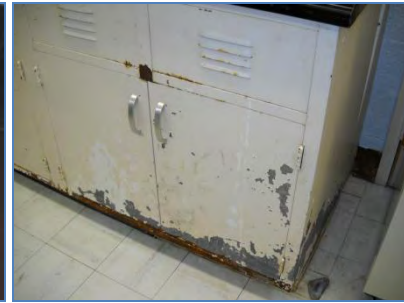
**The photo at left shows a typical laboratory in Bldg 1. Some casework has been painted to extend its life, but generally casework is older and in need of replacement. Some laboratory spaces have severely corroded casework as shown in the next two photos.**

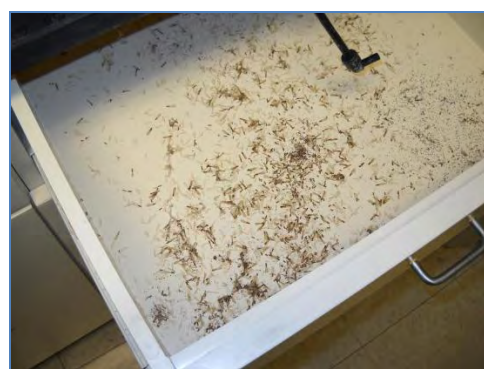
**Dead insects in the drawer of a base cabinet.**

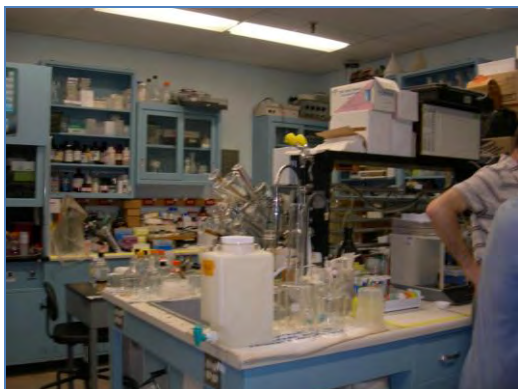
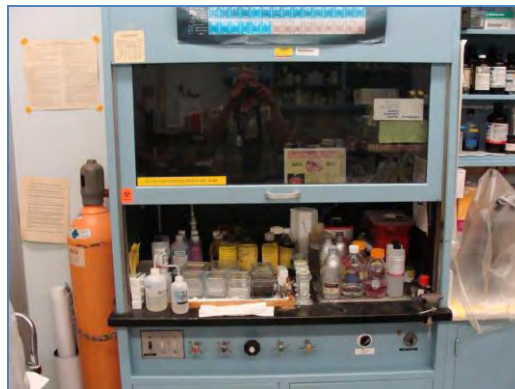
**Some of the laboratories in Building 1 are very crowded. In this one, the fume hood is being used for storage.**

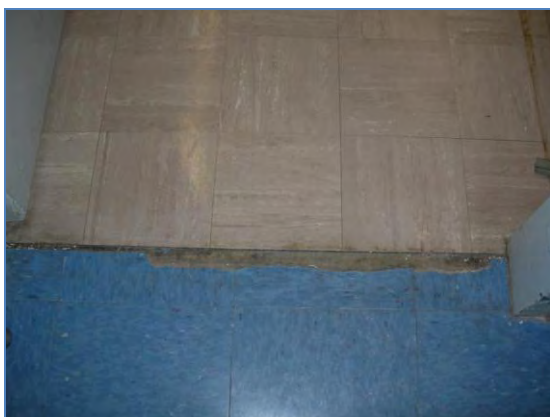
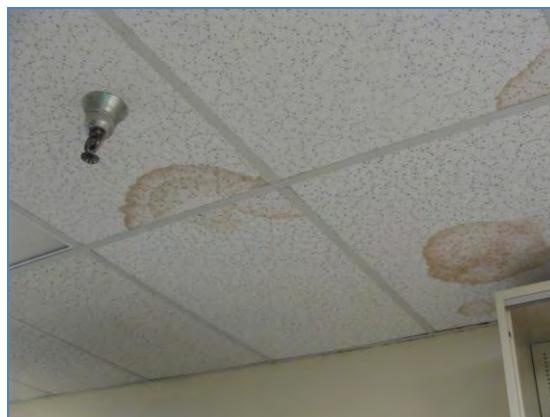
**Some laboratories have evidence of damage within such as this damaged floor at a laboratory entrance (left photo) and the stained ceiling tiles caused by leakage (right photo).**

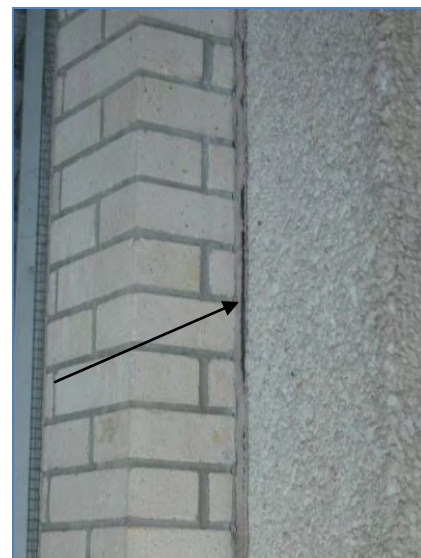
**An open joint at the exterior of Building 11.**

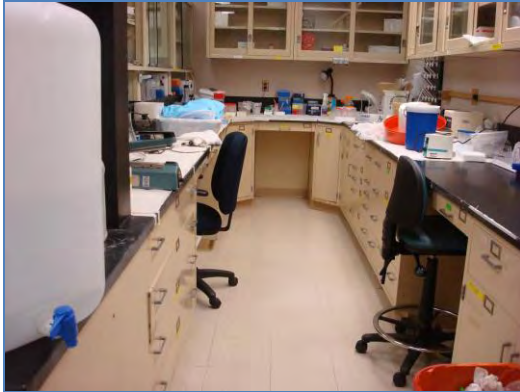
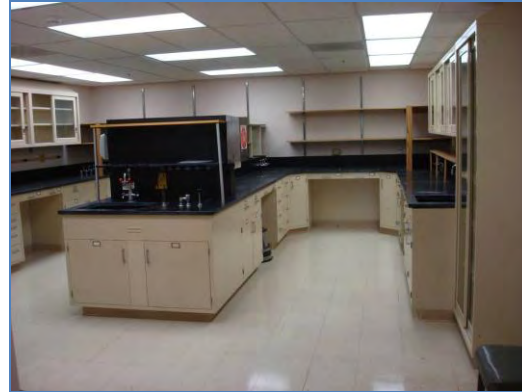
**(Left photo): Some laboratories have very tight spacing between benches. (Right photo): A wider view of a laboratory unoccupied at the time of the assessment.**

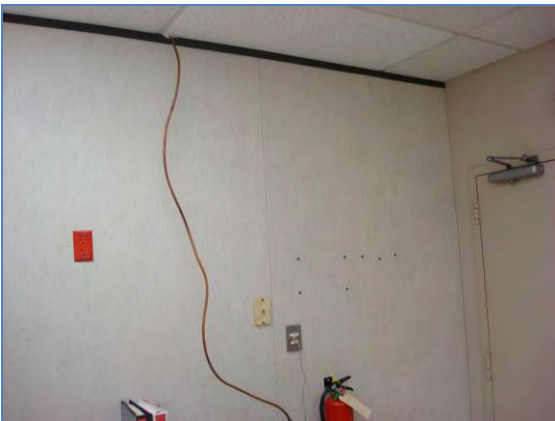
the laboratories are sectioned off with temporary partitions of a type to be found in an office environment. They are not appropriate for use in a laboratory.

**A movable partition used to separate laboratories – this is inappropriate.**

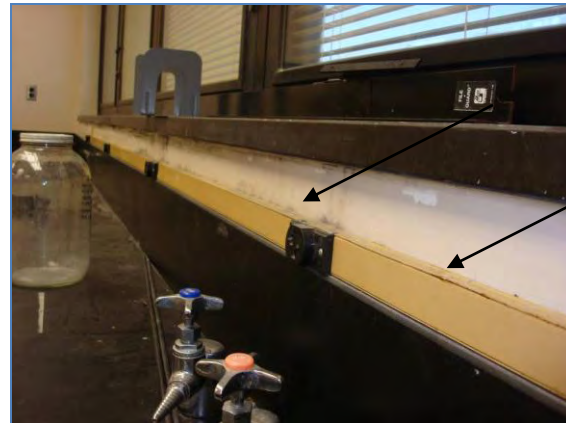
**Evidence of leakage beneath a window (rusted electrical raceway, mold growth).**

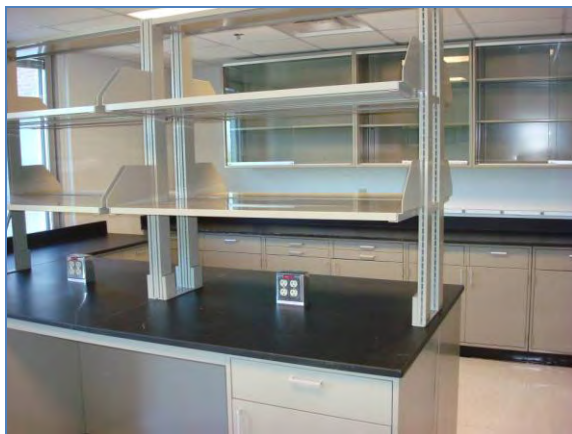
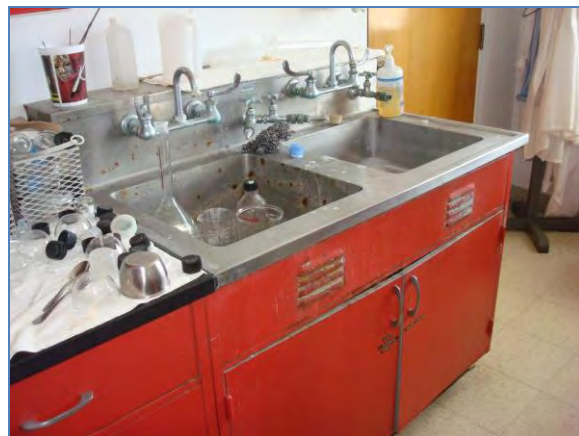
**The photos above show the significant difference between a renovated laboratory (at left) and a non-renovated laboratory (right photo) in Building 1.**

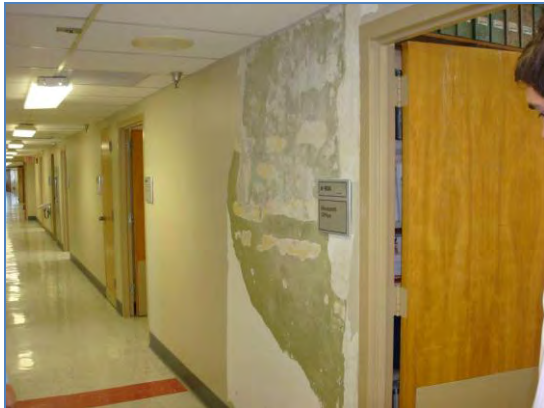
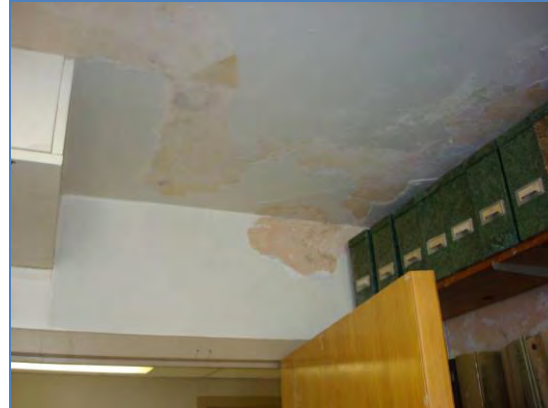
**Roof leaks have resulted in some water damage in Building 1. Both photos above show damage that has partially been repaired.**

Correction of miscellaneous Priority 2 and 3 deficiencies, including repair of damaged finishes, mechanical system deficiencies – (station funds), completed.

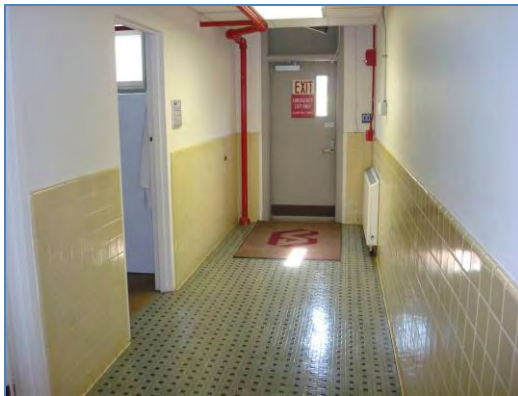
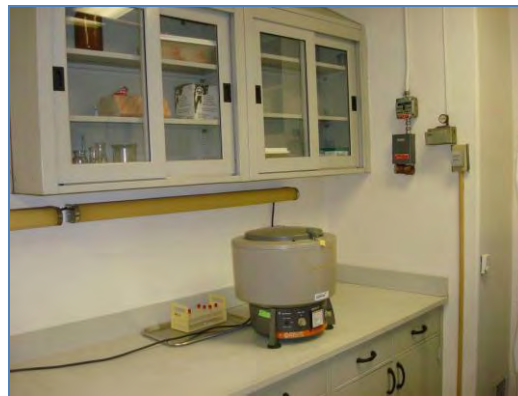
**Building 12 which houses the VMU is in the best condition of all research space on the campus. Shown above at left is the interior view of the VMU's main entrance. The right photo shows a procedural laboratory.**

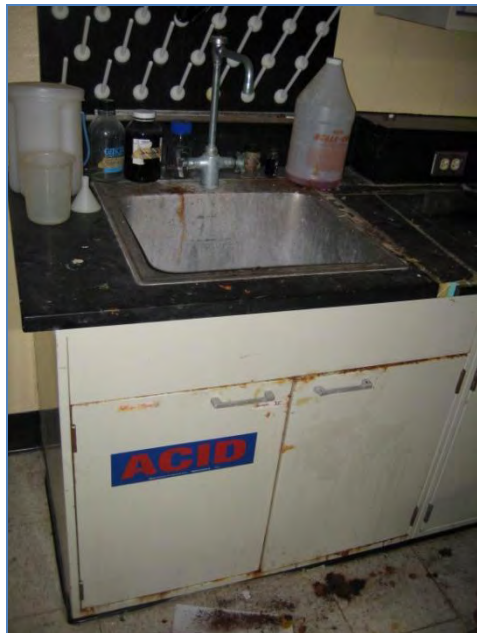
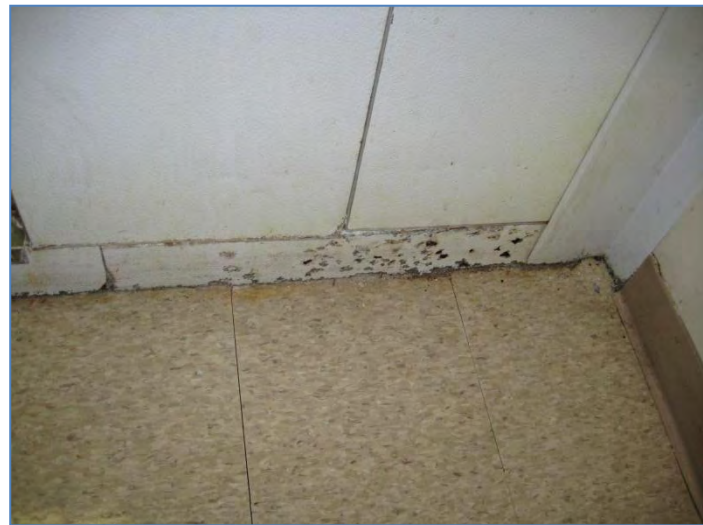
**The photos above and below show Building 1 laboratory space in disrepair and in need of significant renovation.**

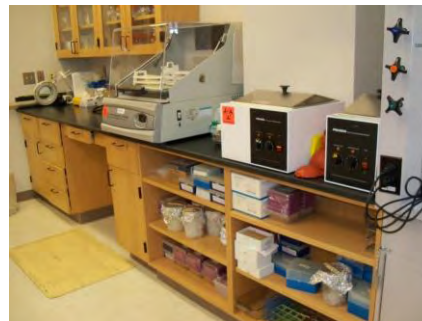
**(Left photo): The overall laboratory design incorporates a light well that links the mechanical space to the laboratories, accommodating utilities and ductwork well while allowing natural light into the spaces. (Right photo): General view of laboratory casework.**

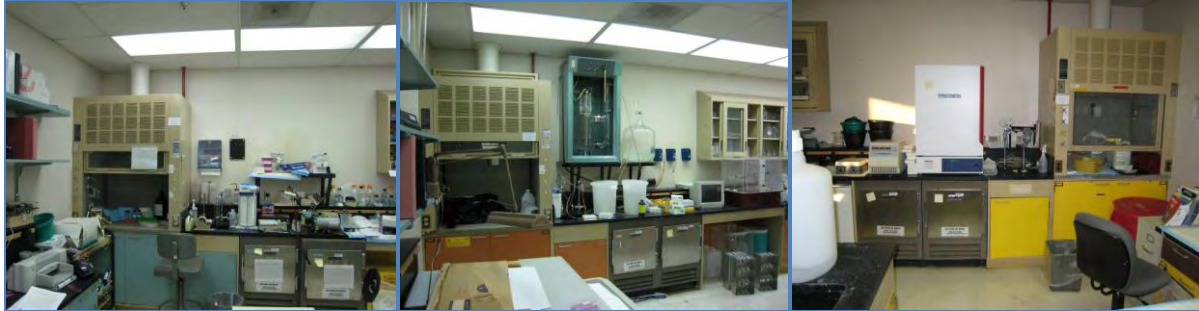
**Since the time of the space assessment, this station has renovated one floor of laboratories and obtained funds to renovate the remaining space. The three photos above show typical laboratories as they appeared at the time of the assessment (December 2007). The photos below show renovated space on the fifth floor. At left is the open floor plan being utilized in the new laboratory design. The photo at right shows one of two animal procedure rooms also located on the fifth floor.**

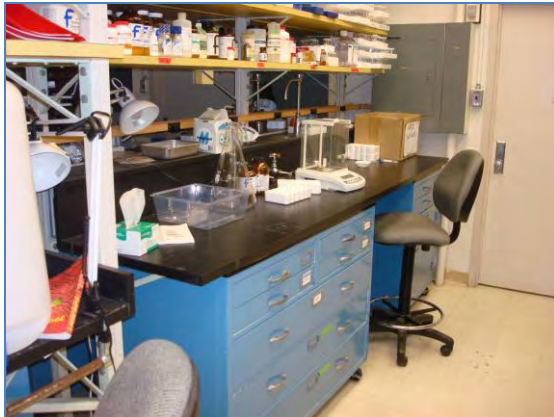
**The laboratories in Building 15 are in need of renovation. The photo at left shows typical laboratory casework with inappropriate plastic laminate countertops. At right, the epoxy flooring in the VMU was deteriorating in spite of being recently updated. The contractor who performed the work was correcting the problem areas.**

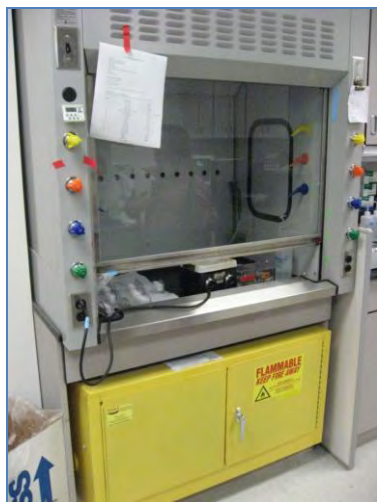
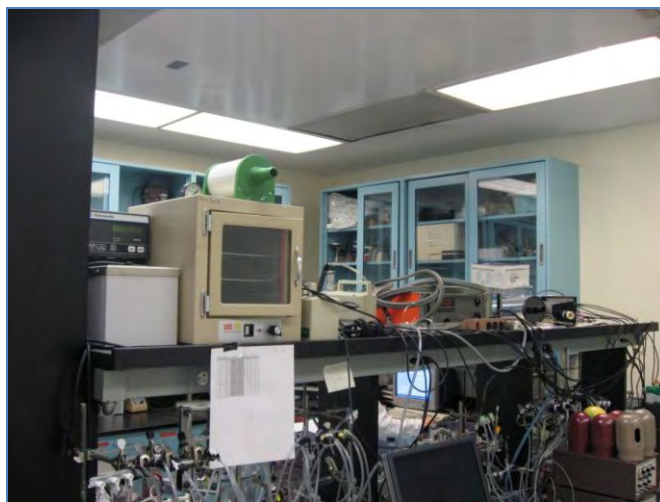
**(Left photo): This new fume hood (in a renovated laboratory) has a removable flammable storage cabinet. The hood converts to an accessible hood. (Right photo): One of two laboratory spaces that has not been renovated.**

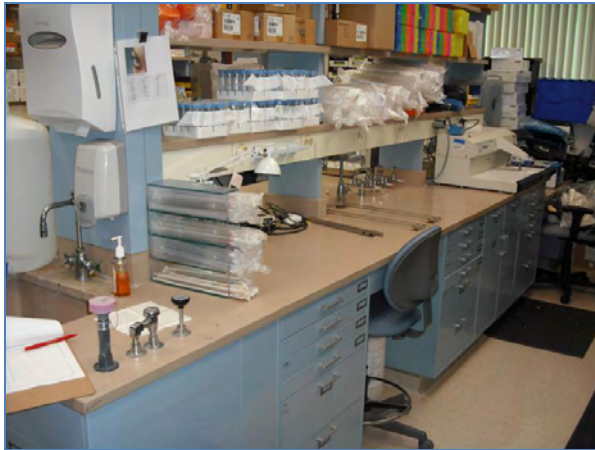
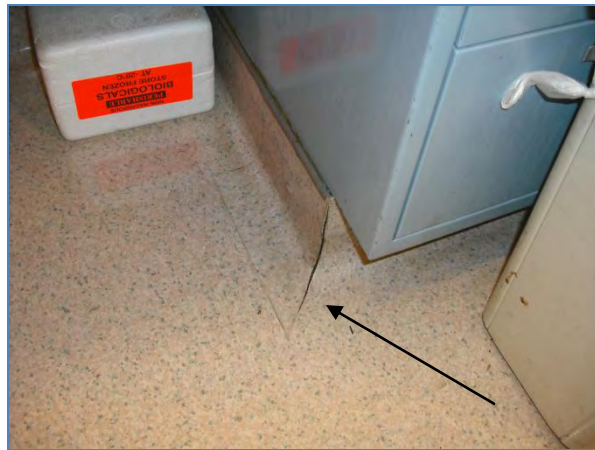
**The photos below are of Building 31. (Left: a typical Bldg 31 laboratory; right: the seamless flooring used in the laboratories is cracking at corners and at the base of cabinets.)**

Building 31 was constructed in 1995. It is a three level building (two floors above ground, plus a basement) that houses laboratories on the top two floors and the VMU on the basement level. Building 31 has very well designed laboratories and support spaces, and laboratory finishes and casework are in good condition. The one exception is a problem with the flooring at the base of casework where the seamless vinyl is cracking.

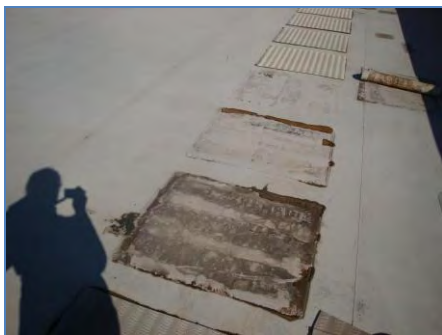
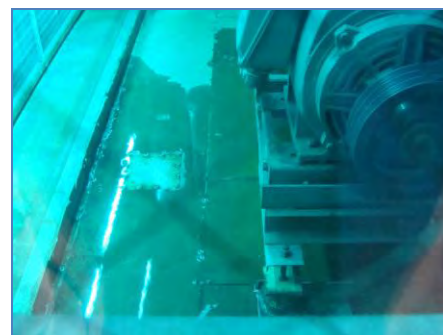
**Building 100 is at the age where significant problems will begin to show. (Left: The roof is not leaking yet, but it is beginning to deteriorate. Center: Evidence of leakage and corrosion at an air handling unit. Right: Standing water in an air handling unit.**

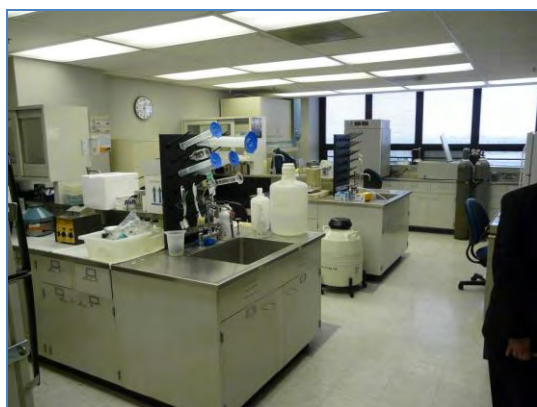
**A typical 3-bay laboratory in Bldg 11A.**

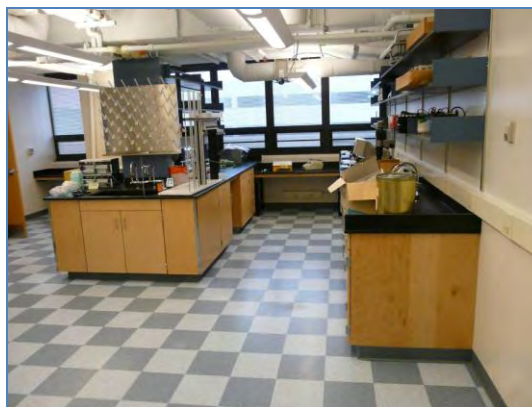
**This laboratory being renovated in 2009 still is not complete.**

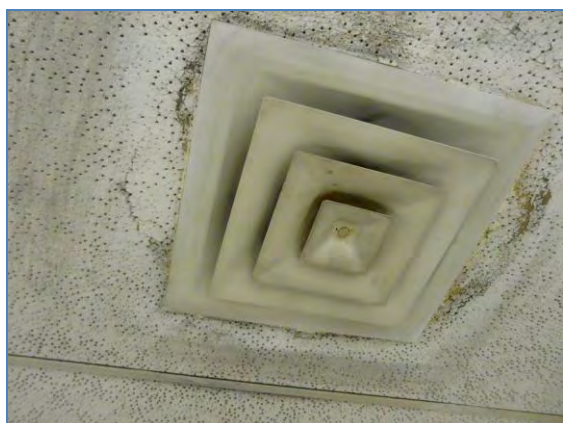
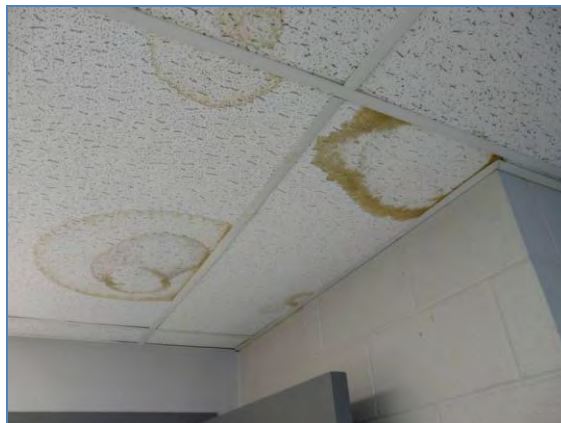
**More views of Building 11A – at left, a dirty HVAC diffuser and ceiling tiles. At right, the ceiling shows evidence of leaks.**

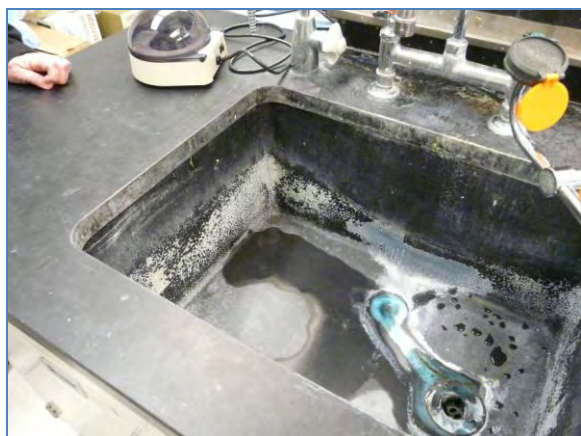
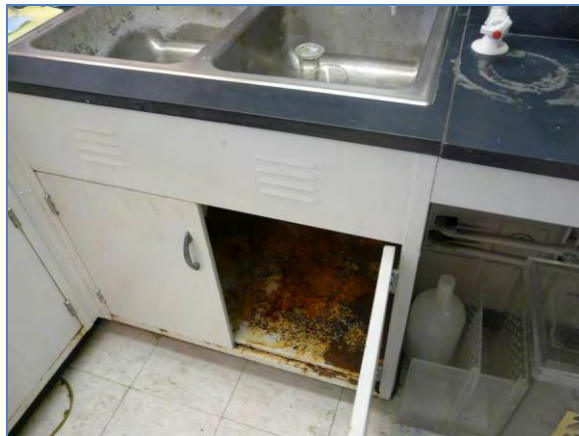
**Below, corrosion is prevalent throughout the space (left photo: corroded epoxy sink; at right, rusted sink cabinet). Both photos below were taken on the seventh floor.**

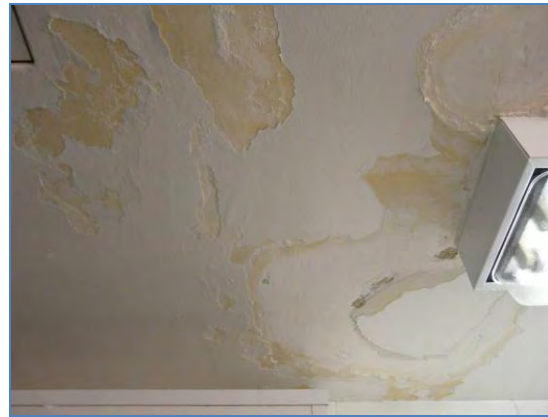
**Evidence of leakage in the VMU.  
A significant leak in May 2010  
necessitated evacuation of animals.**

No improvements have been made to the research space. Continued roof leaks have caused evacuation of the affected space, including one affecting the animal facility. There still is no emergency power for the laboratory or animal research space; only three emergency outlets have been installed for freezers. Additionally, safety deficiencies still exist.

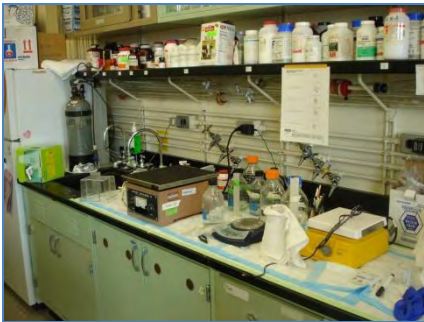
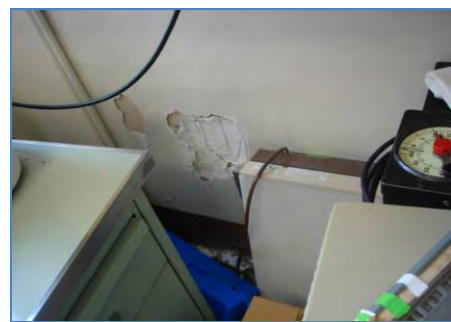
Building 1, which is the original hospital on the Madison VA campus, was constructed in 1949. Biomedical research laboratories are dispersed among the three wings of Building 1, as well as G Wing, Building 13. Condition of the laboratories varies somewhat dramatically, with the space on the fourth floor of C Wing being in the worst condition partly due to its age (over 40 years), but also because of damage from a major roof leak. This space is generally in substandard condition.

**C Wing laboratories are in the worst condition. Shown above are (left to right): typical C Wing laboratory casework; damaged sink in a C Wing laboratory; and wall damage.**

Renovation of research laboratories and correction of roof leaks, Building 1, C Wing, to be completed by mid-2012 – (ARRA funds), design almost complete, construction to begin immediately following.

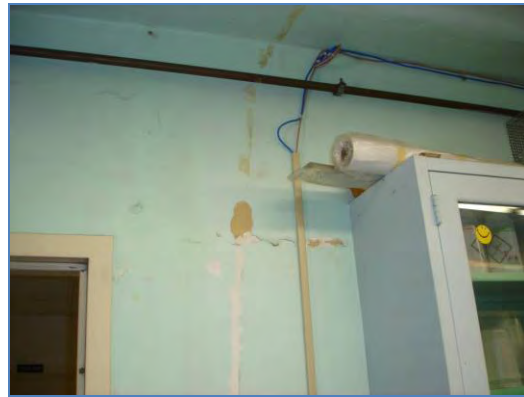
**Evidence of water damage is prevalent.**

Most interior finishes are generally in fair condition, with some deterioration noted. Since the roof leaks, deterioration is likely to continue as the building continues to experience water damage. The casework, as well as laboratory equipment, is generally original to the space and in need of replacement. In addition to suffering from corrosion and other deterioration, the casework is not optimally configured (i.e., the countertops are only 24" deep). Some of the flooring contains asbestos.

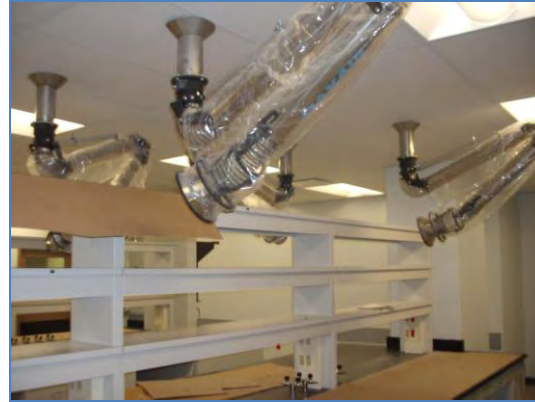
**With the exception of A Wing, laboratory space has been renovated. The photo at left shows an A wing laboratory. The photo at right shows a recently completed but not yet occupied laboratory on F Wing.**
