# Final Report of the VA Research Infrastructure Program

**Veterans Health Administration  
Office of Research and Development  
July 2012**

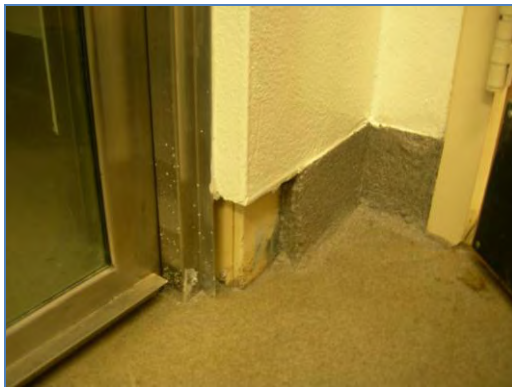
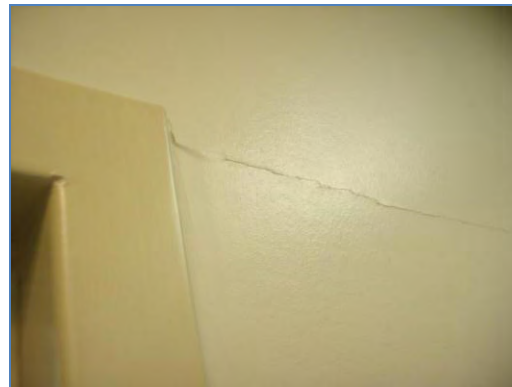
**There are a few damaged finishes in the space. The photo at left shows damage to a wall base in the VMU. At right, the drywall around a door frame is cracked.**

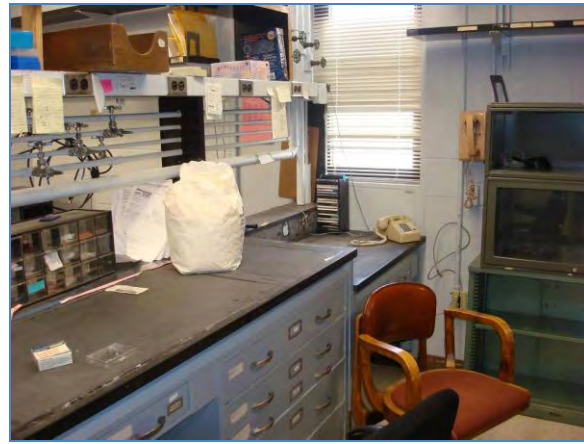
**A laboratory in Building 15.**

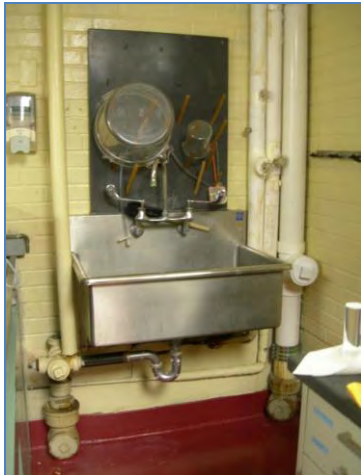
**Rusted exposed piping in an animal use area.**

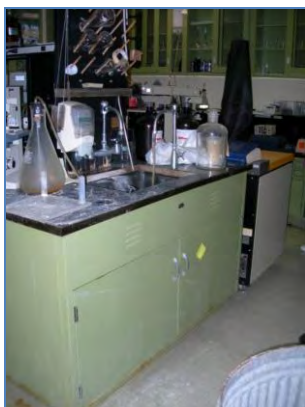
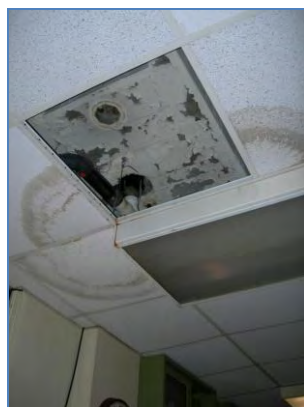
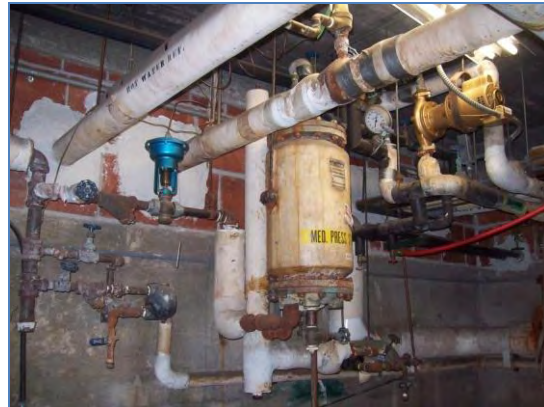
There has been significant water damage to this building. In addition to the common deficiencies described above, Building 7 has significantly aging/damaged finishes as well as casework throughout. Although the roof was replaced fairly recently, there is evidence of possible continued leakage into the building.

**Views of Building 7: (left to right) a typical laboratory, a water damaged ceiling, and an aging heat exchanger.**

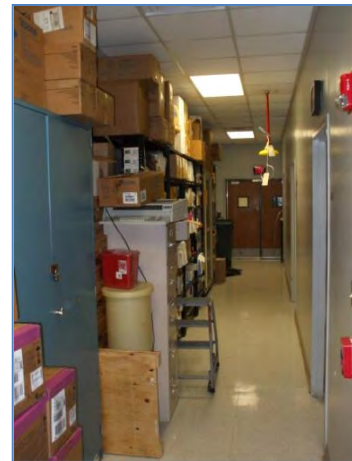
**The photos above are examples of corroded casework (left), damaged finishes (center), and crowded conditions (right) in Building 109.**

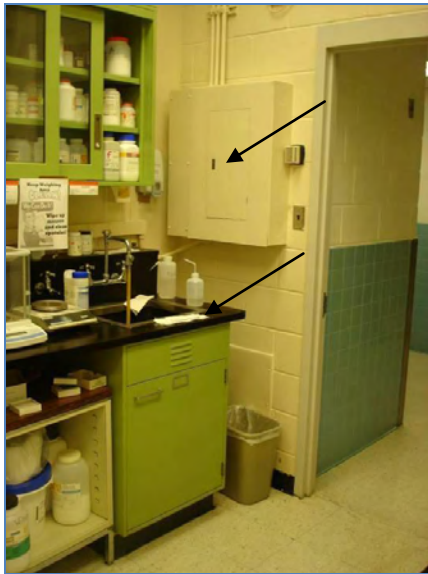
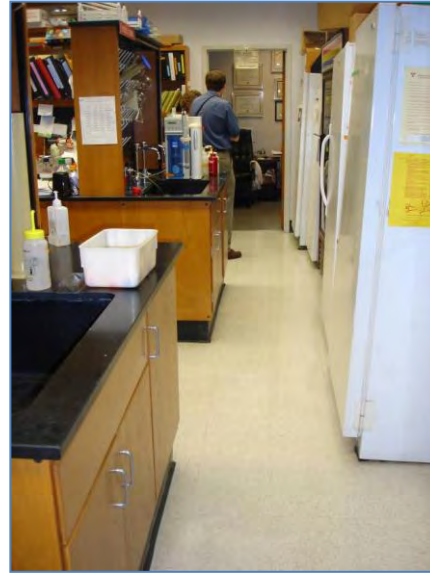
**Left photo: Having a sink directly beneath an electric panel is a significant safety concern. Right photo: Storage of equipment within the laboratories results in lack of accessibility.**

- Receptacles in the VMU are not ground fault protected.
- Eyewashes are needed in the laboratories (current units do not meet requirements).
- Safety showers are needed.
- The fire alarm system is deficient (poor installation, limited smoke detection and notification).
- In at least one laboratory, an electric panel is located over a sink.
- There are no fire dampers in the ventilation system.

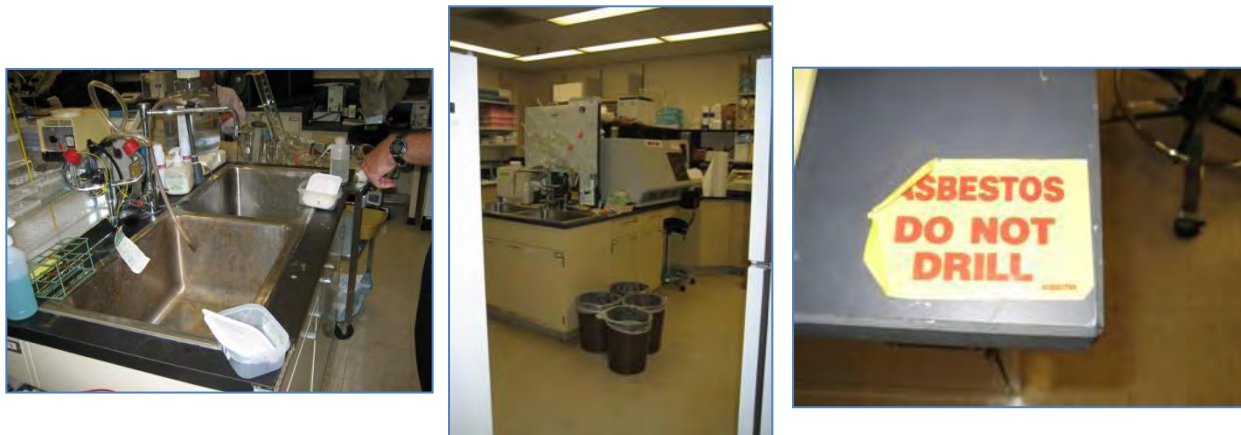
Most laboratories are fairly spacious with an island configuration that includes sinks. A number of these sinks need replacement and have contributed to deterioration of surrounding casework and countertops. Casework, in general, is in moderately good condition but could use repainting or, in some cases, replacement.

### **Examples of typical laboratory conditions at the Little Rock VAMC.**

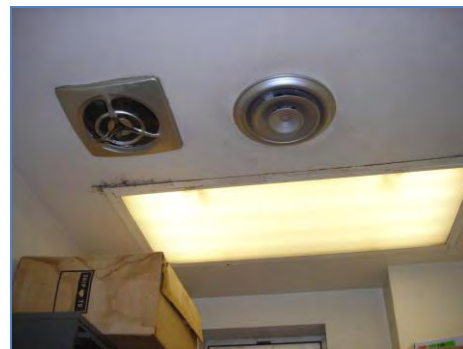
**Interior spaces of Building 19 show evidence of water damage caused by the exterior seals between pre-cast panels (mechanical vertical shaft) either missing or deteriorated (left photo). At right, a deteriorated laboratory ceiling.**

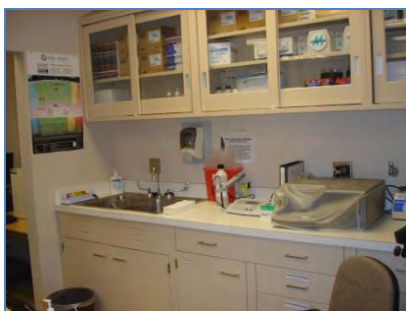
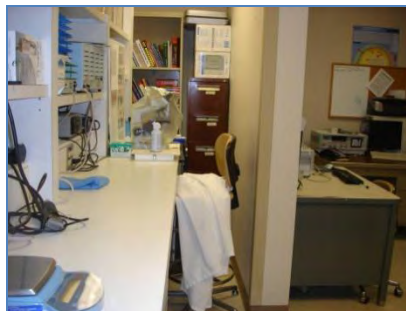
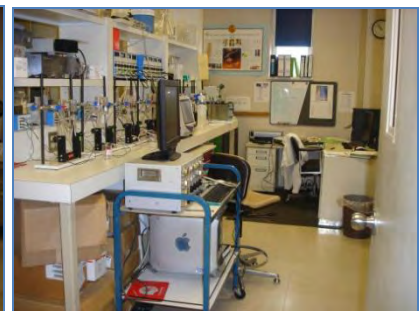
**Typical laboratory views. Note the shallow countertops (24 inches rather than the standard of 30) at left, and tight working conditions on other two photos.**

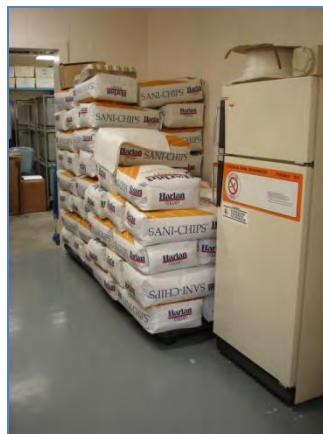
The VMU is located in an addition (South Wing) to Building 10 constructed in the 1970s. Generally, the interior construction of the VMU is in good condition, but there are several problems including roof leakage, peeling epoxy floor finishes, and some significant equipment that is inoperable or continuously fails. The VMU area is not covered by a sprinkler system.

**The VMU in Building 10 (pictured above) will be renovated beginning in FY 2012.**

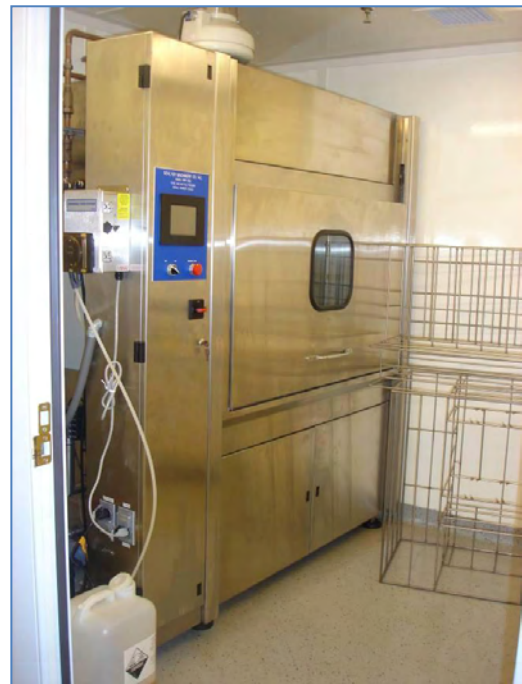
**At right, the cage washer in Bldg 21B is a relatively small unit.**

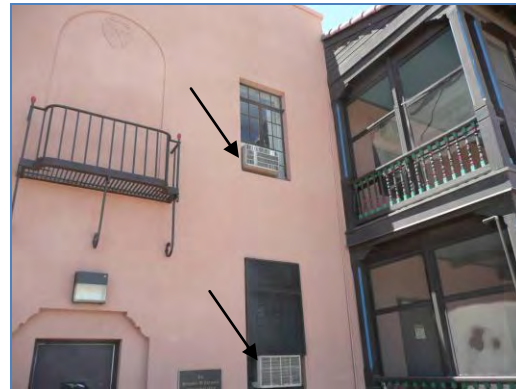
**Above left, a typical laboratory in Building 6. At right, this view of the exterior shows the window air conditioning units.**

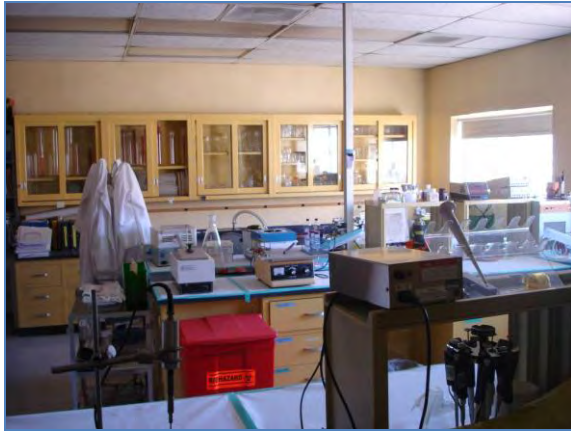
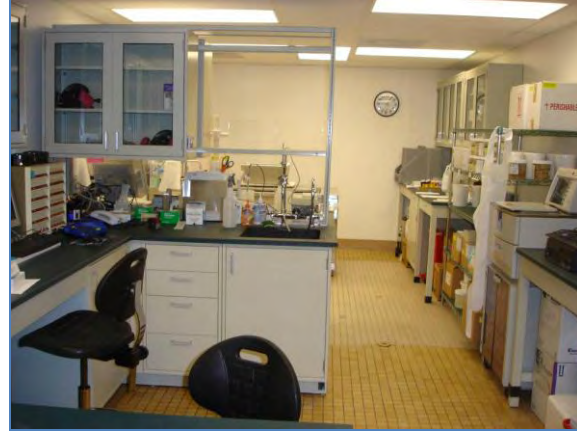
Building 10 received the worst rating of all buildings on the Tucson campus.

**The photo at left shows a typical Building 10 laboratory. At right, the few laboratory spaces in Building 38 are expected to be lost for medical records storage.**

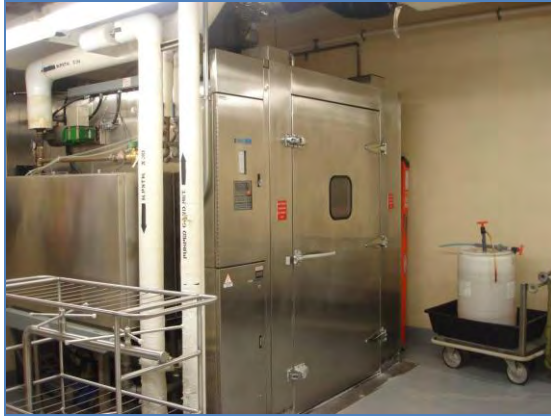
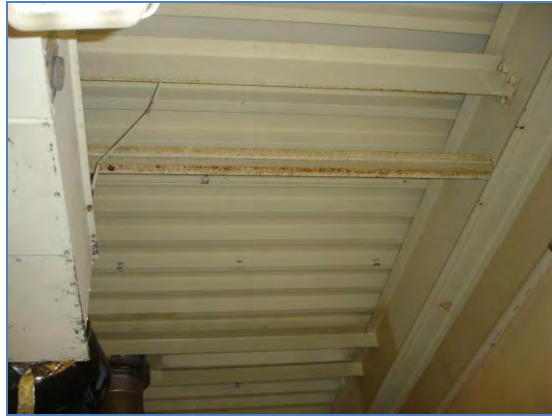
**Above left, the VMU cage washer (Building 56) lacks an exhaust hood over the door to catch escaping steam. This can cause damage to interior finishes such as the corrosion seen in the roof metal deck of the cage washer room (photo at right).**

Building 56, which houses the VMU and the BSL-3 laboratory, was built in 1980, with an addition in 1987. The containment laboratory was converted in 2001. Finishes in the VMU are in very good condition. There is a need to install a canopy hood on the cage washer to help reduce heat in the cage wash area.

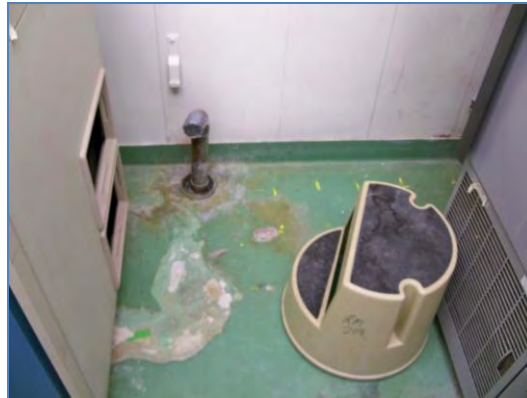
**(Left) In Building 21, room 21-310, there is an electric panel over a sink. The photo at right shows damaged flooring in Building 21.**

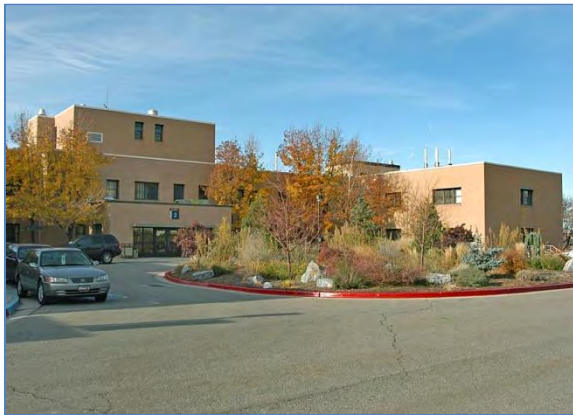
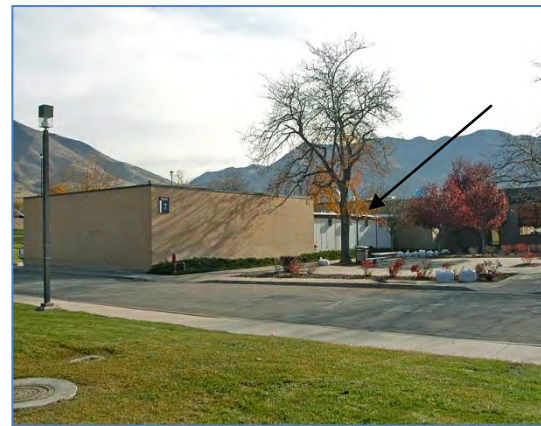
**(Above left) Building 2 houses the newest laboratory space on the campus and provides the best opportunity for expansion of space. (Above right) Building 7, with its two component buildings joined by a modular structure (see arrow), is not an optimal environment for a VMU.**

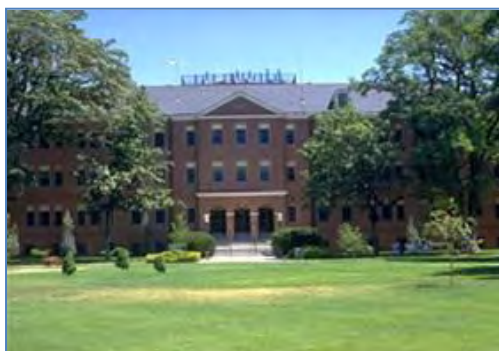
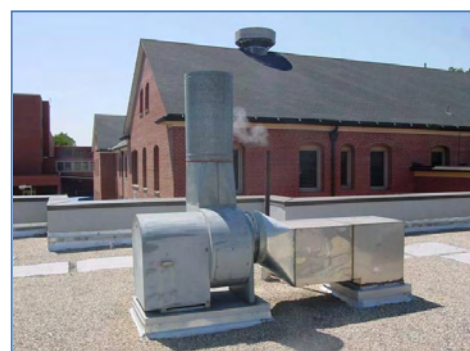
**At left, Building 67 houses research laboratories in converted clinical laboratory space. At right, rooftop equipment on Building 109.**

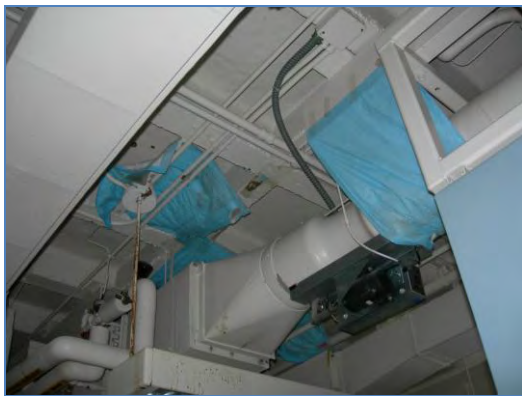
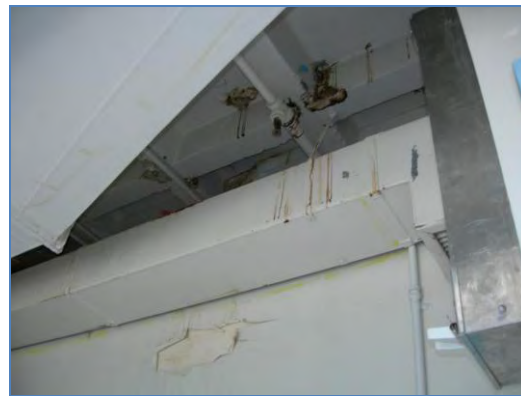
**Above, leaks are prevalent in Building 1, due to roof leakage, mechanical equipment, and penetrations.**

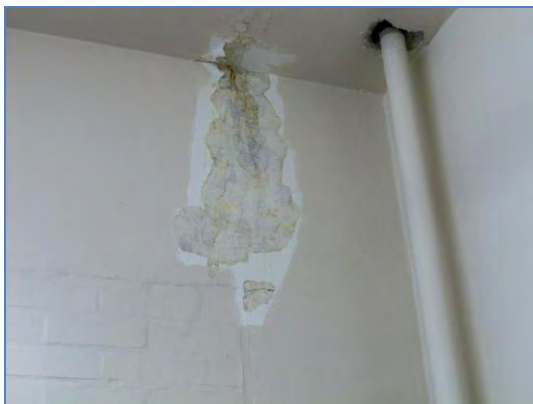
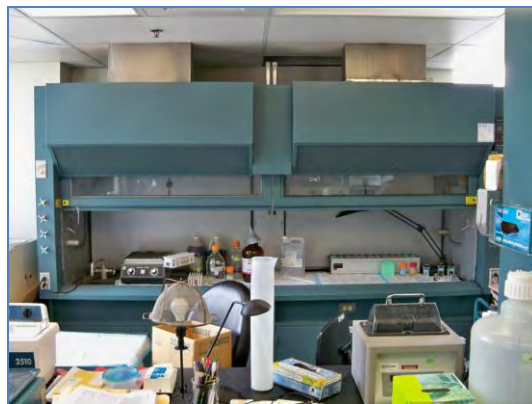
**Below (left), Building 8 also has leakage problems causing damage to interior finishes. At right, an aging fume hood in a Building 8 laboratory.**

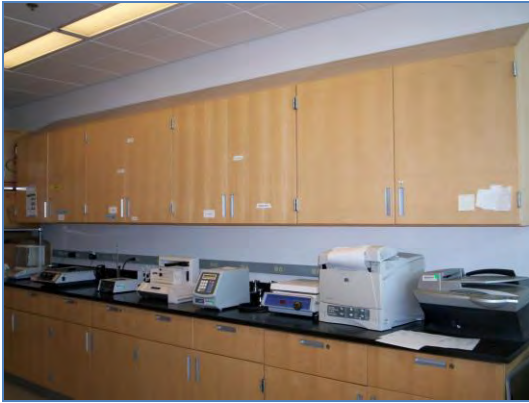
**(Left photo) Typical casework in the Mather campus laboratories.**

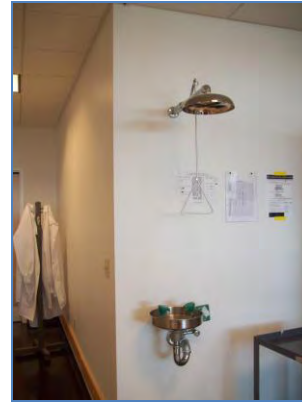
**(Right photo) Typical safety shower with emergency eyewash in laboratory area corridor.**

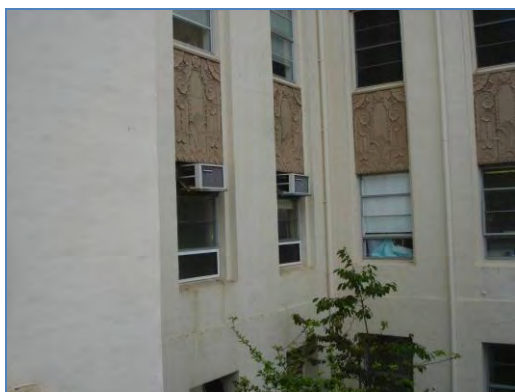
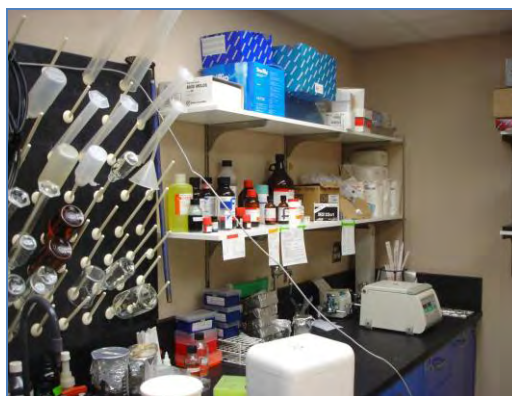
**(Above left) Many buildings on the San Francisco campus are lacking central ventilation systems, as pictured here in Building 1. (Above right) A laboratory in Building 2/4/5. Note the lack of seismic lips on the reagent shelving above the casework.**

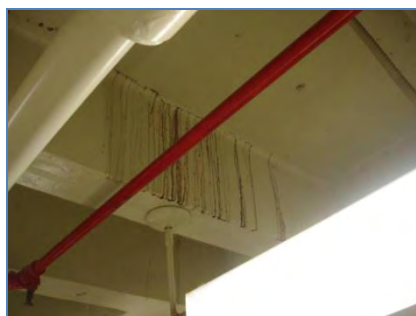
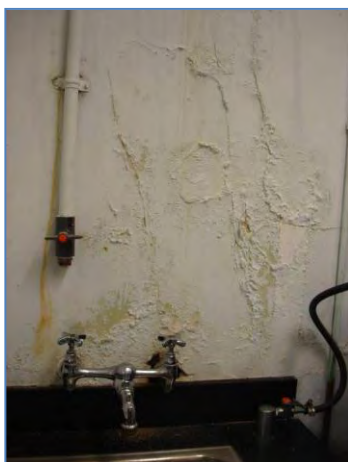
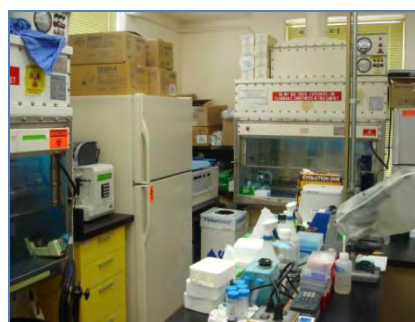
**(Photos below are of Building 12) Left to right: Note the lack of ceiling and the stains from leakage; a damaged wall; and very crowded conditions in a laboratory.**

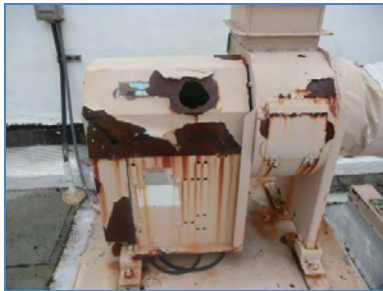
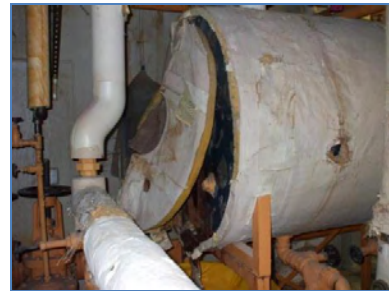
**The coastal environment has been very harsh to equipment, as seen in the mechanical system components above.**

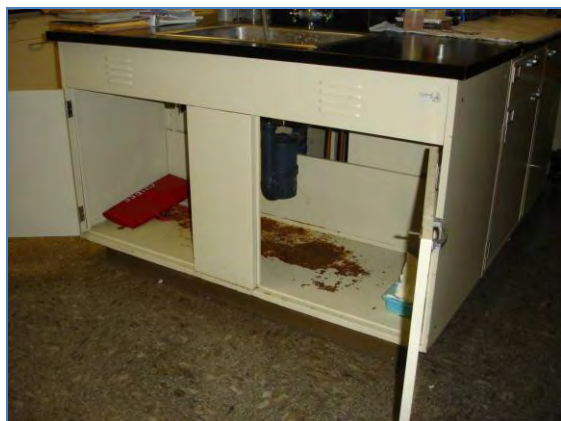
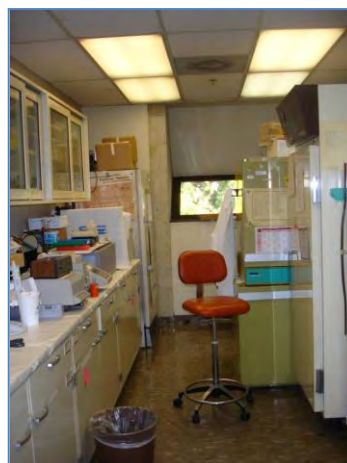
**Corroded conditions beneath a laboratory sink; a typical laboratory with crowded conditions; ficus tree roots trying to grow into the building; and a typical laboratory sink.**

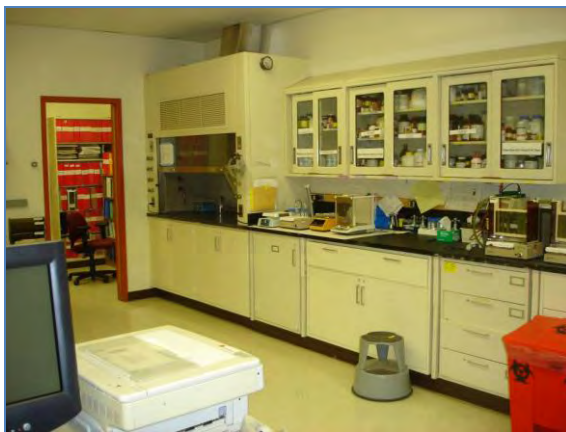
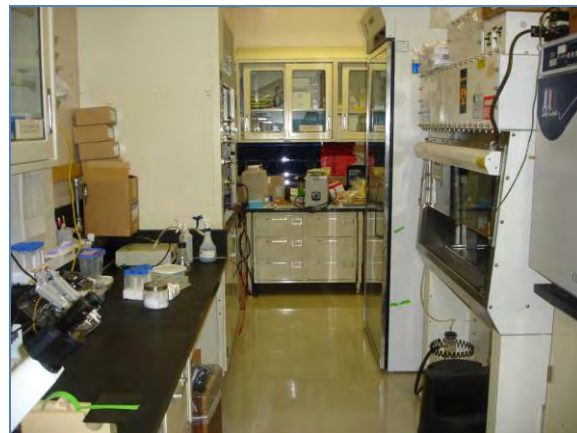
**(Left photo) A typical laboratory. (Right photo) Accessibility in some laboratories is restricted.**

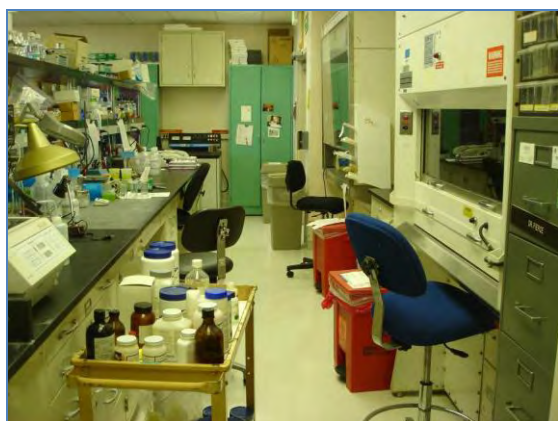
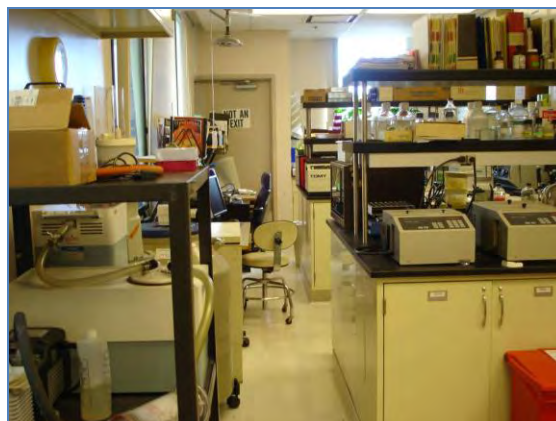
**Examples of overcrowded conditions in research laboratories.**

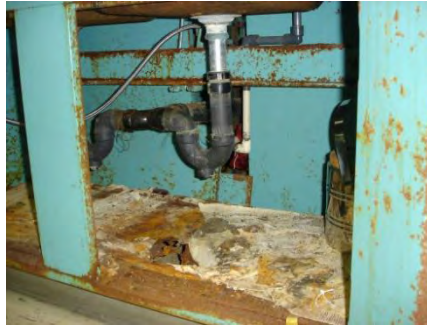
**Examples of laboratory casework in poor condition.**

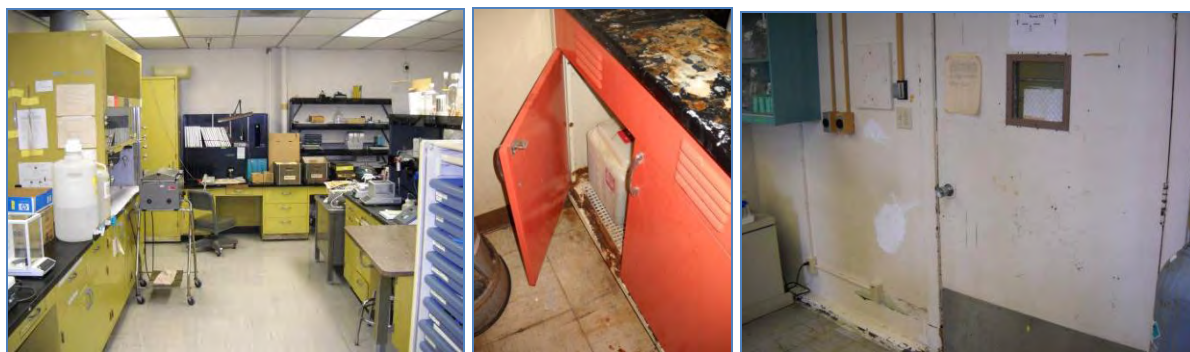
**Conditions in Building 113**

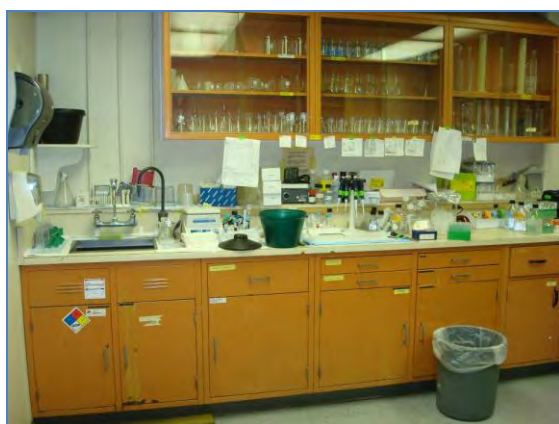
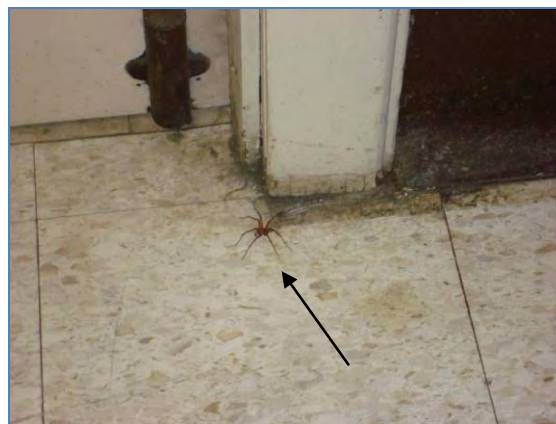
**Conditions in Building 114 (note the spider at right)**

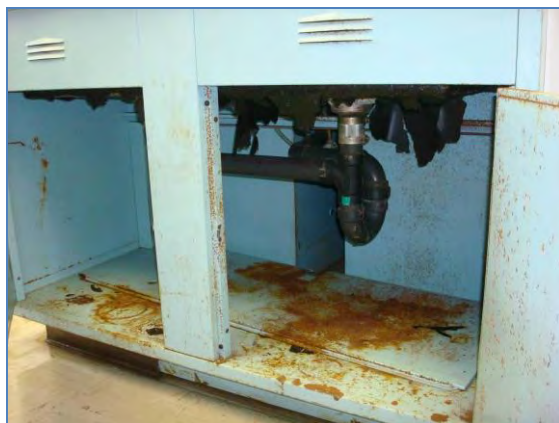
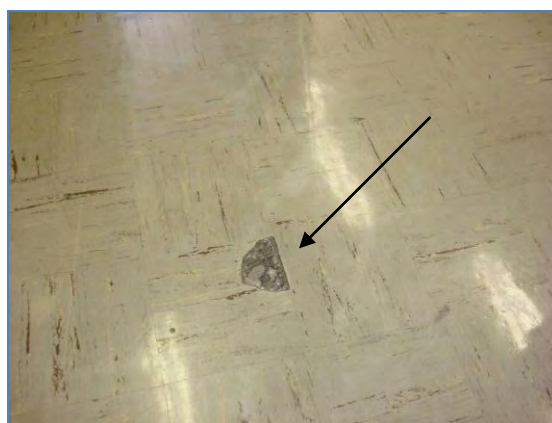
**Conditions in Building 115. The photo at right shows chipped asbestos tile.**

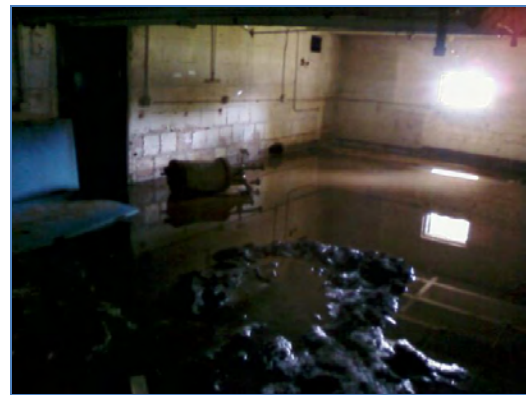
**Conditions in Building 117 which houses a portion of the VMU. Note the water standing in the basement in the photo at right. (The basement houses mechanical equipment, not animal research space.)**

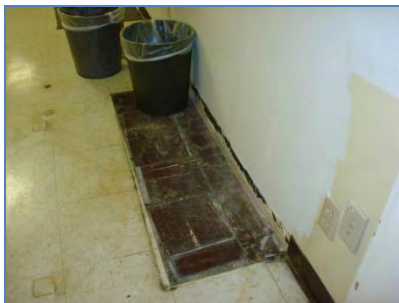
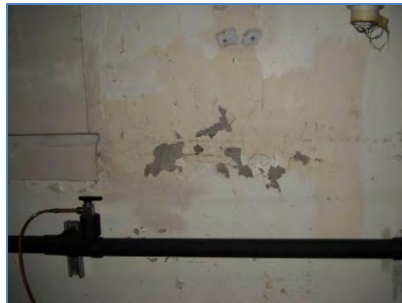
**From left to right, damaged asbestos flooring in Building 210; a damaged wall finish in Building 212; and a laboratory in Building 258.**

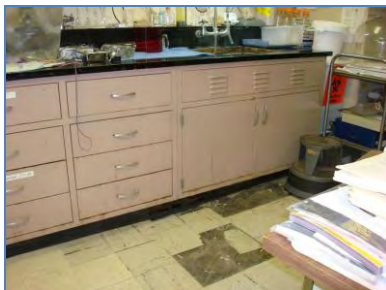
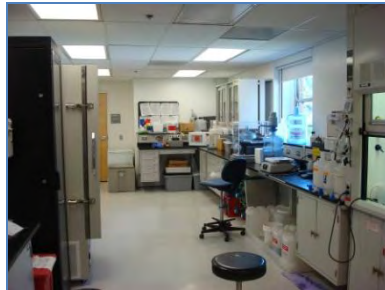
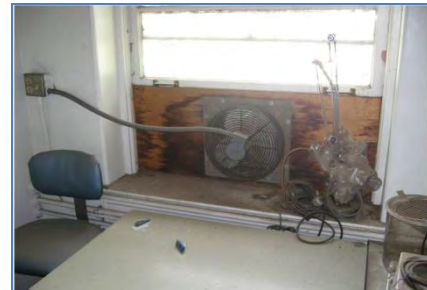
**Left to right (above), a Building 1 laboratory with significant damage to asbestos flooring; a typical laboratory in Building 7; a window mounted "exhaust" fan, Building 62.**

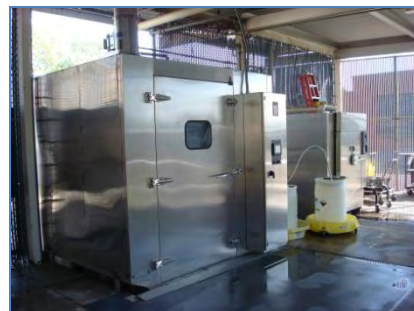
**Left to right (below), part of the Building 47 cage washer is outdoors (the arrow is pointing to a bird's nest); Building 103 also has an outdoor cage washer.**

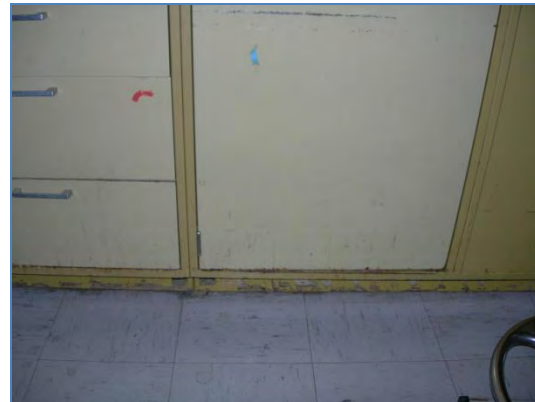
**Above, deteriorated wall and ceiling finishes (left) and casework (right) in Building 1 laboratories.**

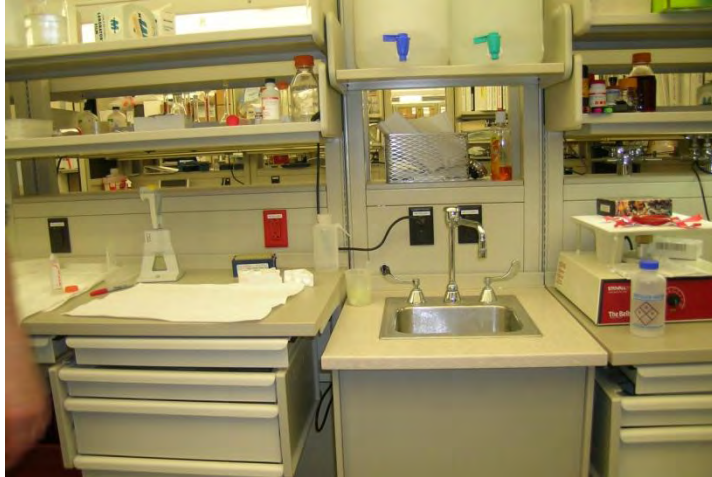
**This casework (pictured in Bldg 40) is typical of the laboratories in both Buildings 40 and 41. Note the receptacles over the sinks are properly ground fault protected.**

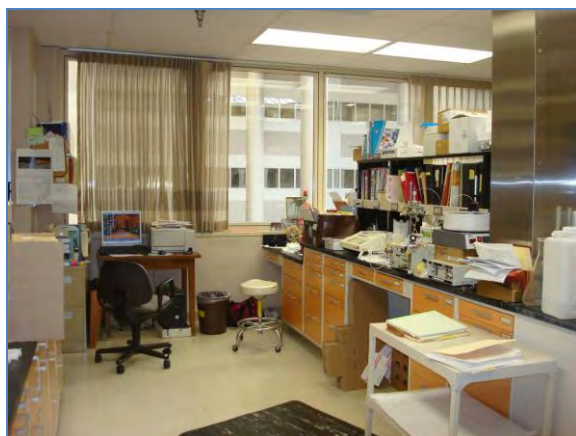
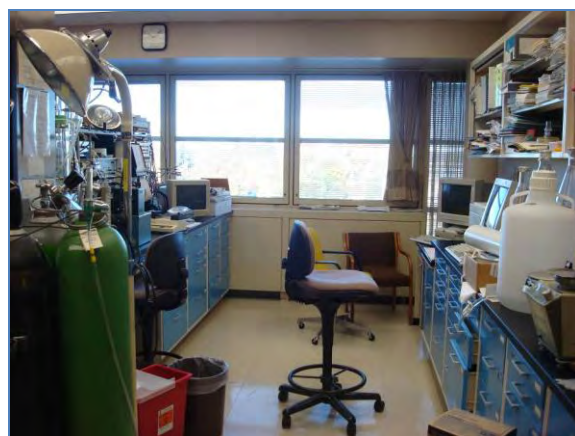
**Two examples of Building 70 laboratories.**

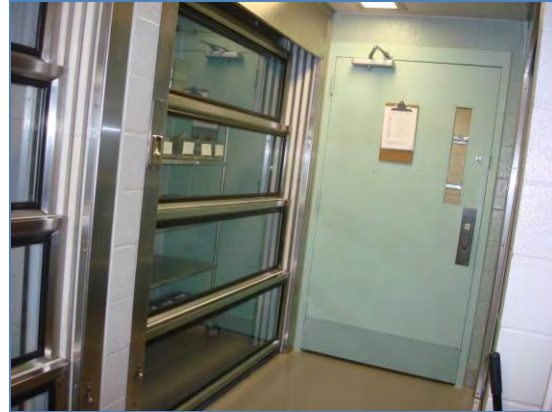
**(Left) A laboratory in Building 49. (Right) Animal housing booths in the VMU.**

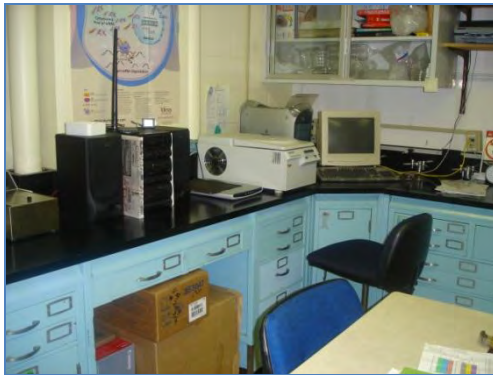
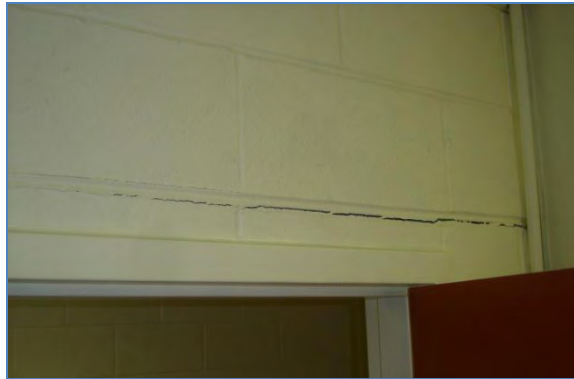
The building and supporting systems have been well maintained but many systems and materials are reaching or have already reached the end of their expected life cycles. Throughout the laboratory areas, the metal casework is generally near or at the end of its life cycle, although some of the casework is in at least fair condition. There are problems with flooring in some of the laboratory areas, primarily with the type of flooring used as being inappropriate for a laboratory environment. Fixed equipment is overall in fair condition with some having been replaced in recent years. Some cracks in interior walls were noted. While these cracks may not necessarily be due to structural problems, they are in some cases allowing water leakage.

**(Left) A typical laboratory in Building 15. (Right) Cracks were noted on interior walls throughout the space.**
